# Pinellas Trail and Sunset Point Road Crossing After Conditions Technical Memorandum

Prepared for:  
Forward Pinellas

Prepared by:  
AECOM  
7650 West Courtney Campbell Causeway

July 2022

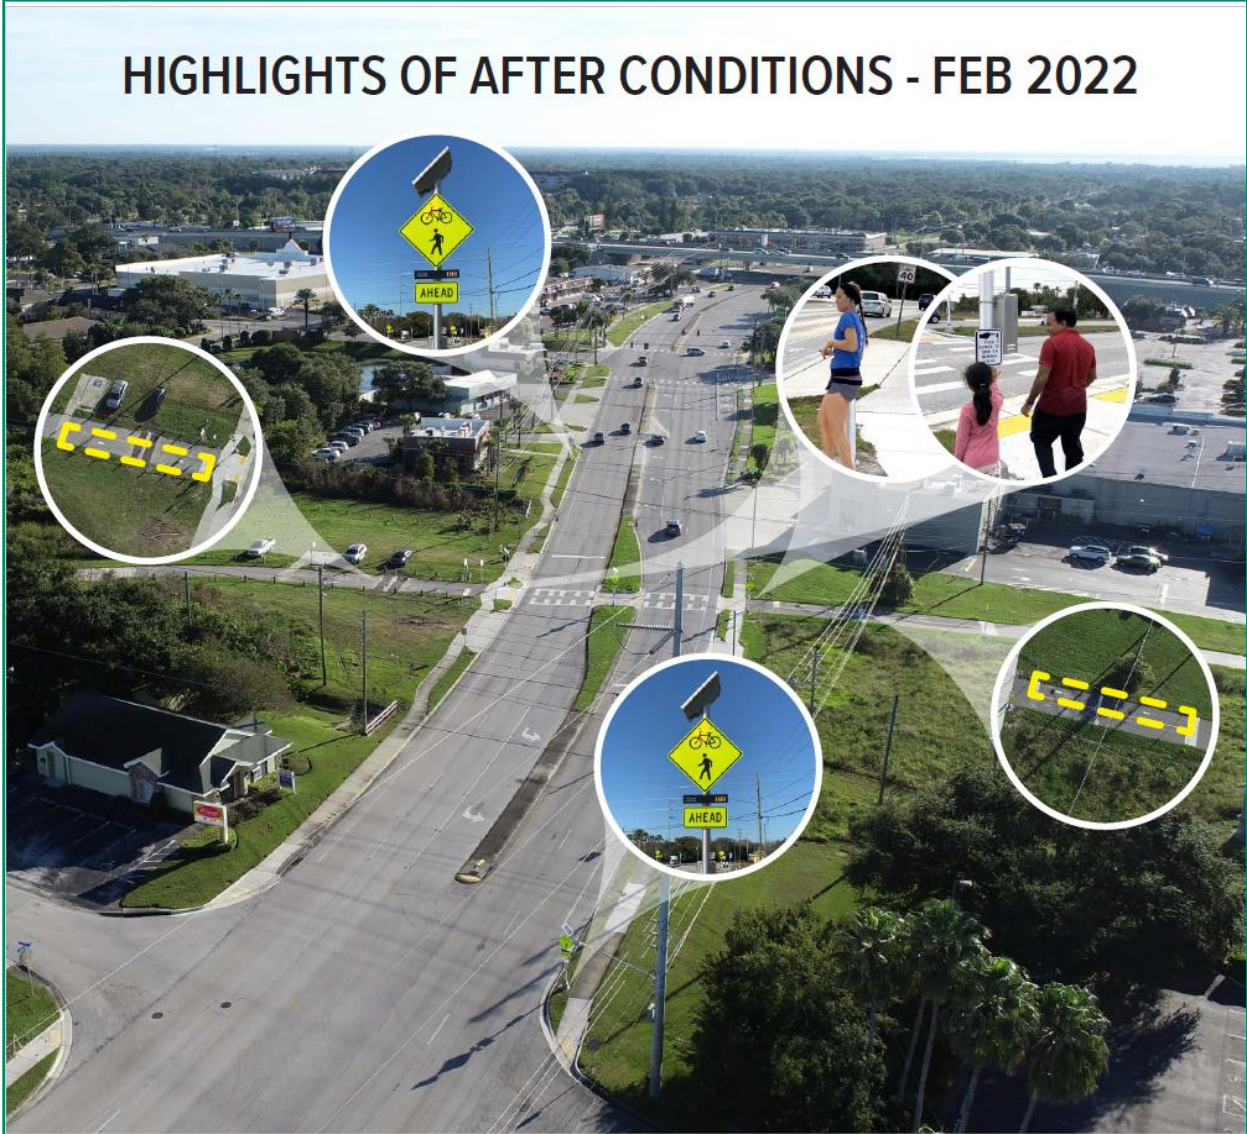
Based on comments by residents as to the failure of vehicles to yield consistently, even with RRFBs activated, the County programed upgrades to crossing in late 2021. Highlights of the improvements included revising signage; restriping directional traffic on the Pinellas Trail; adding a second activation pole on each side of the Pinellas Trail; and installing new warning RRFBs (activated at time of crossing) over 120 feet prior to the crossing.

**Figure 1-1: Highlights of After Conditions Improvements – February 2022**

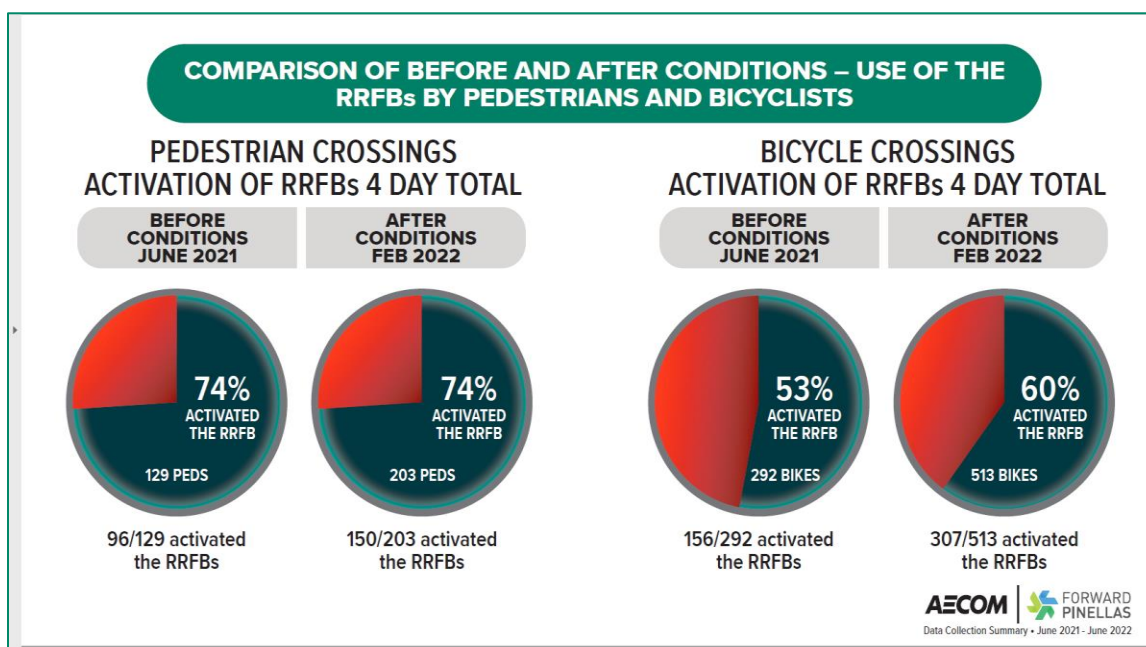
A comparison of the use of the RRFBs for both pedestrians and bicyclists is summarized in the graphic, **Figure 2-1**. Activation of RRFBs for pedestrians showed the same 74% usage for both months. Activation of RRFBs for bicyclists showed an increase usage from 53% to 60%.

**Figure 2-1 Comparison of Before and After Conditions, Use of the RRFBs by Pedestrians and Bicyclists**

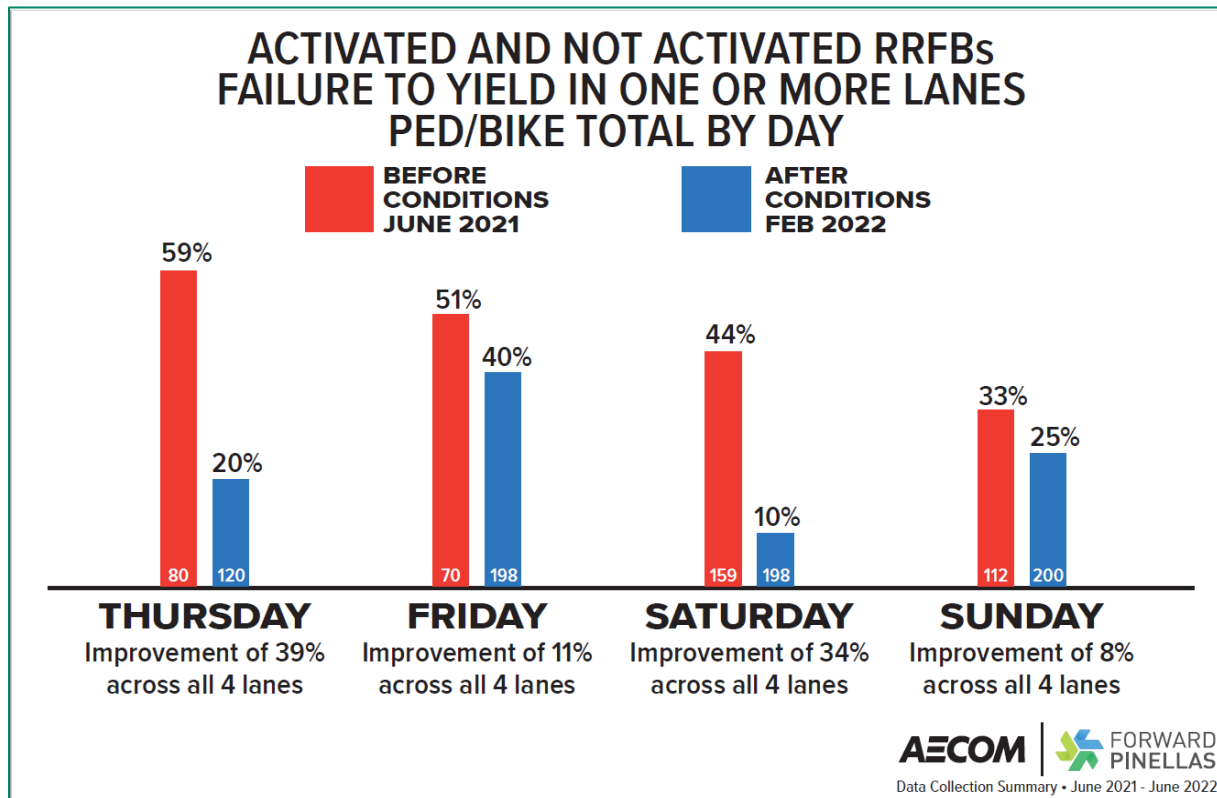
**Figure 2-2 Activated and Not Activated: Failure to Yield in One or More Lanes Ped/Bike Total by Day**

The findings indicated that activating the RRFBs improved the likelihood vehicles would yield for pedestrians and cyclists crossing at the Pinellas Trail and Sunset Point Road. Activating the

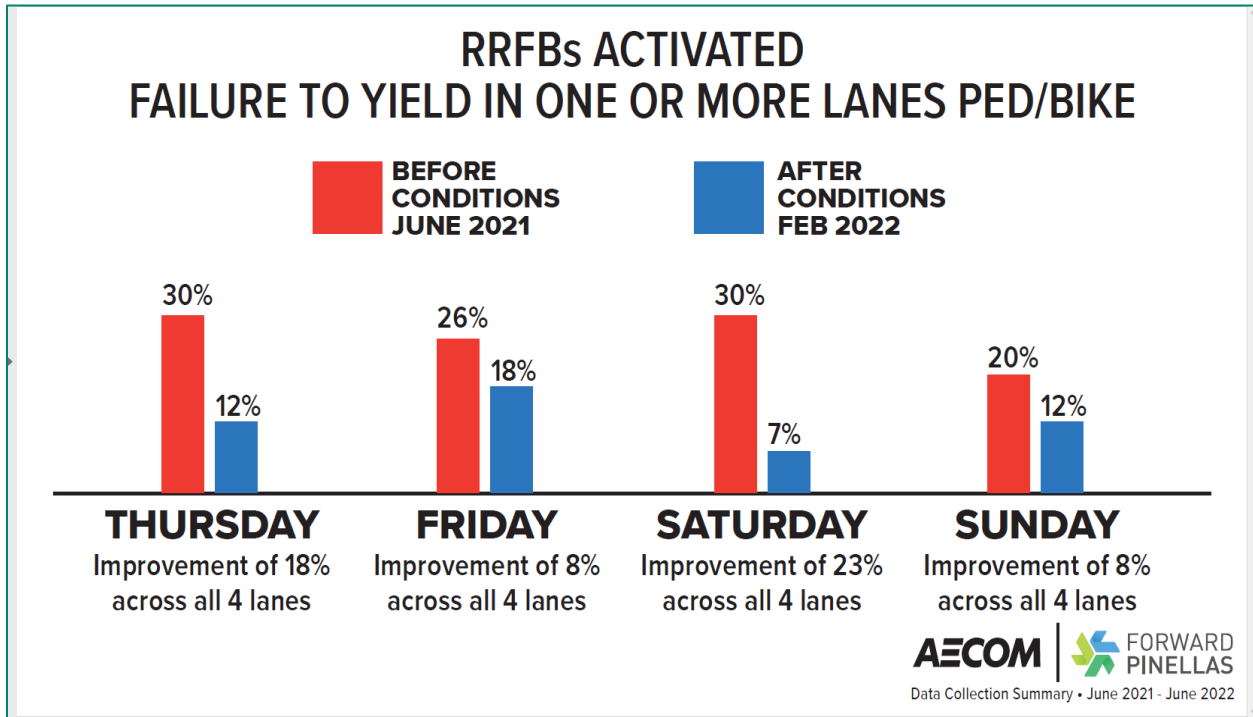
**Figure 2-3 RRFBs Activated: Failure to Yield in One or More Lanes Ped/Bike Total by Day**

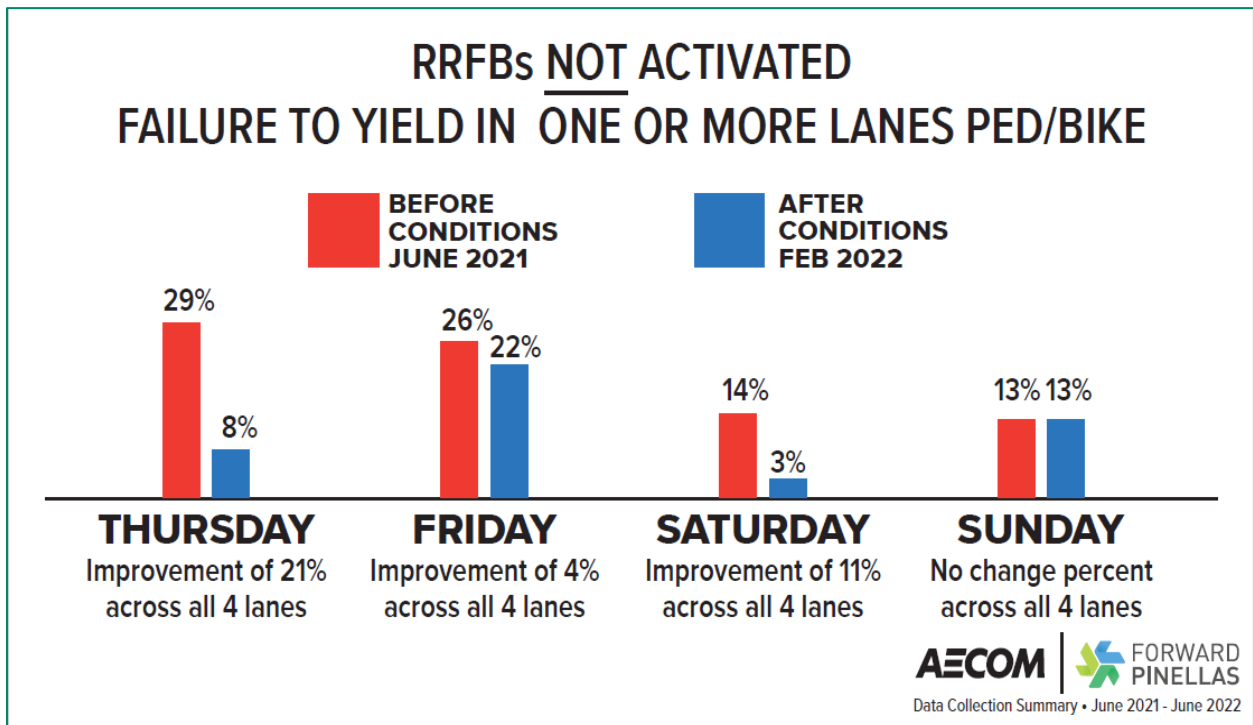
**Figure 2-4 RRFBs Not Activated: Failure to Yield in One or More Lanes Ped/Bike Total by Day**

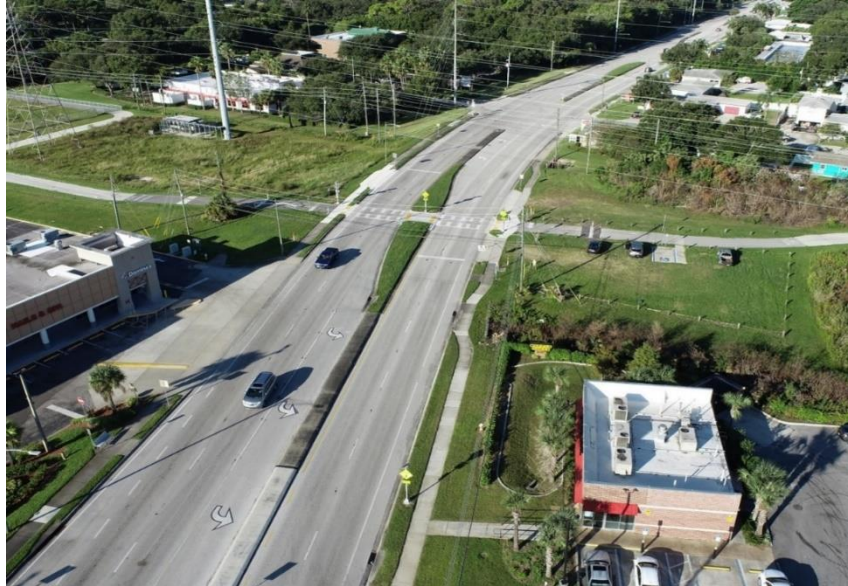
The crossing is located on a four-lane divided section of Sunset Point Road with a posted speed of 40 MPH and includes a refuge median with the option to activate the RRFBs in the median, as well on the north side and south side of the Pinellas Trail. A signalized intersection is located in close proximity (to the east) of the crossing. Aerial views of the crossing are provided.

**Figure 2-5 Pinellas Trail and Sunset Point Road Crossing: Looking West**

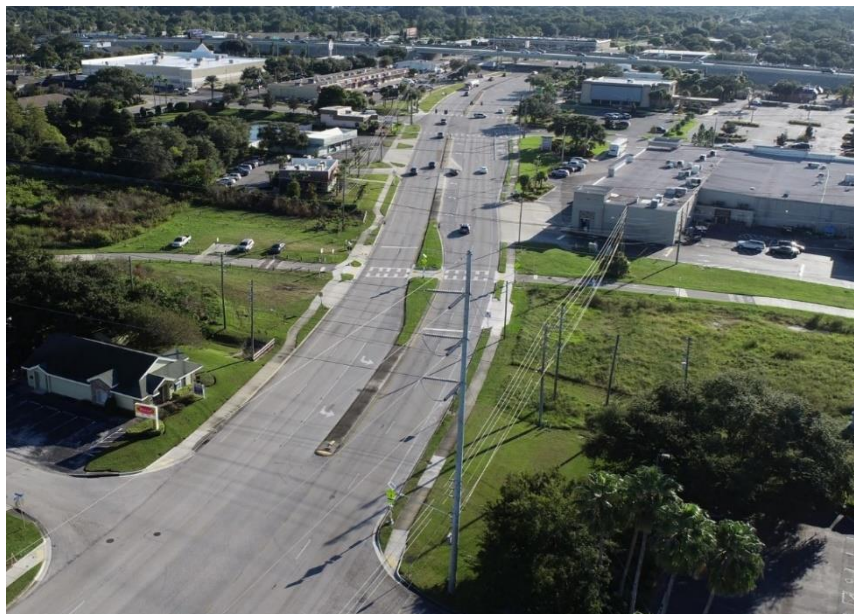
**Figure 2-6 Pinellas Trail and Sunset Point Road Crossing: Looking East**

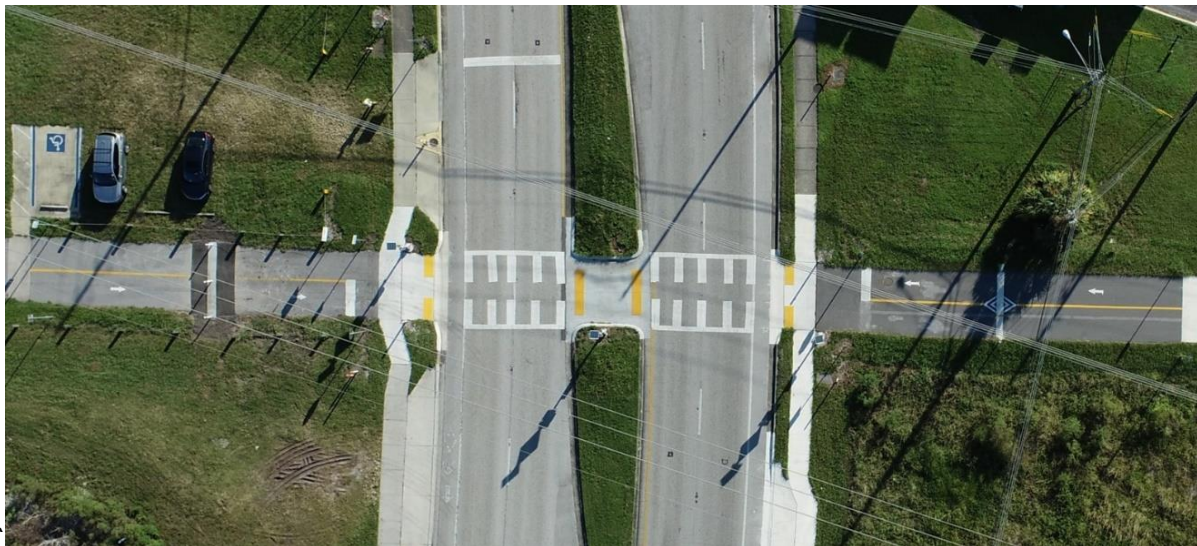
**Figure 2-7 Pinellas Trail Striping Improvements: Right Lane Travel for all Users**

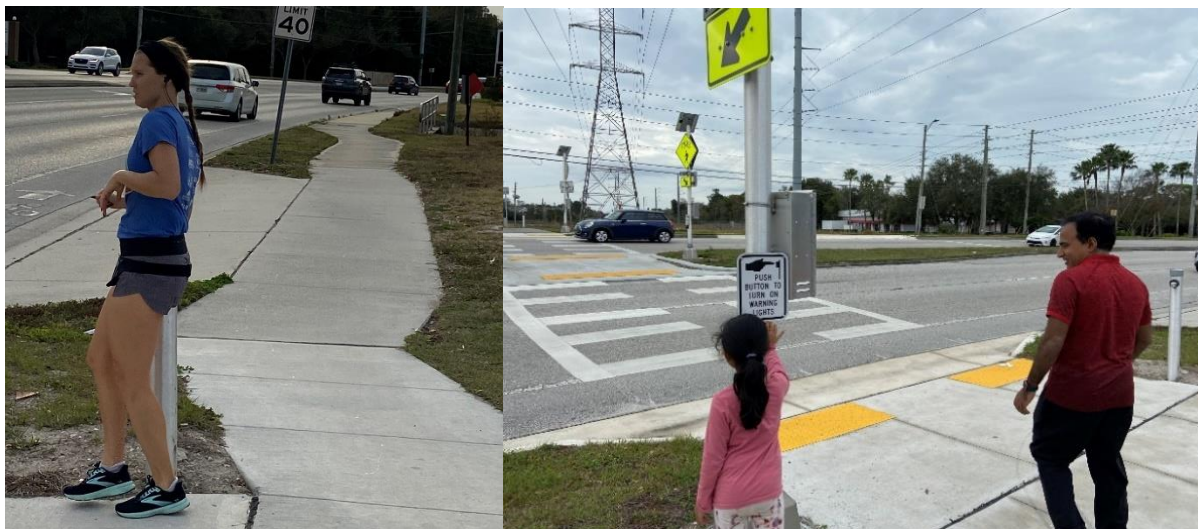
**Additional RRFB Activation Pole – A Second Pole Added to Improve Access**

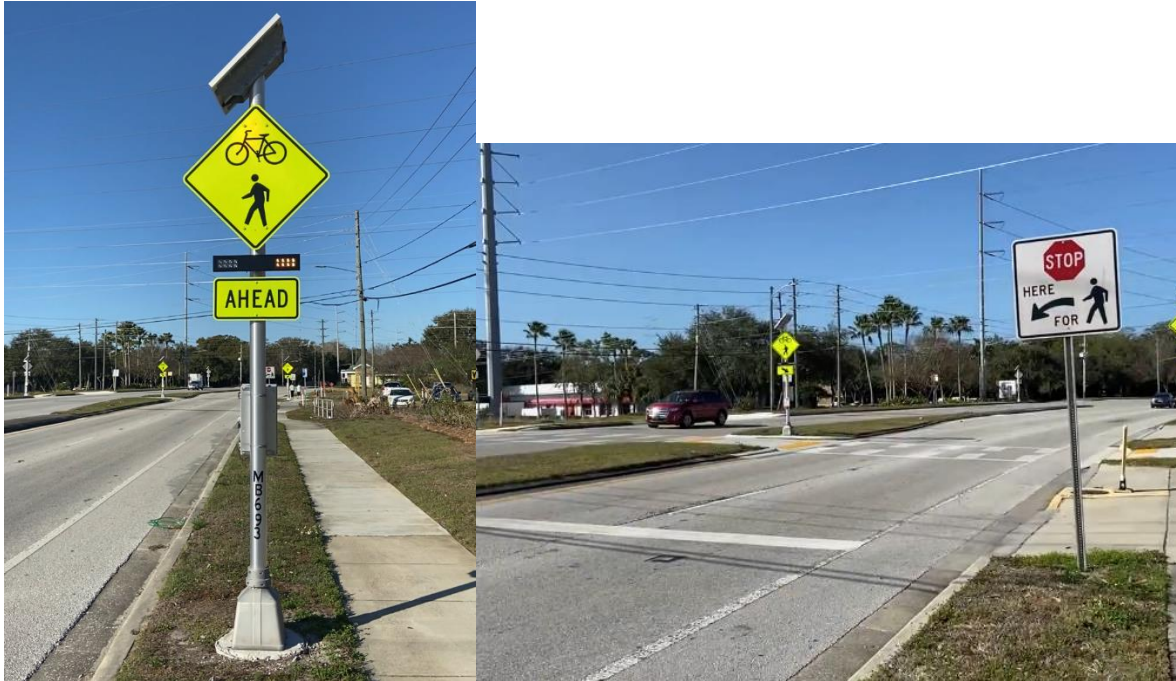
**Sunset Point Road – Warning RRFBs Added on Approaches to Trail Both West and East. In addition, the “Stop Here” Signs were Maintained within 40 feet of Crossing West and East.**

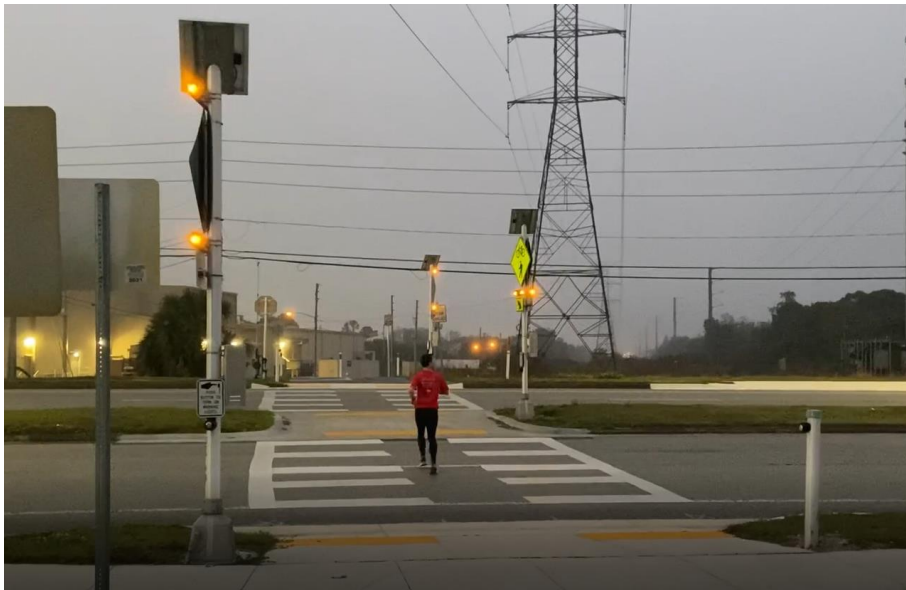
**Enhanced RRFBs Lighting**

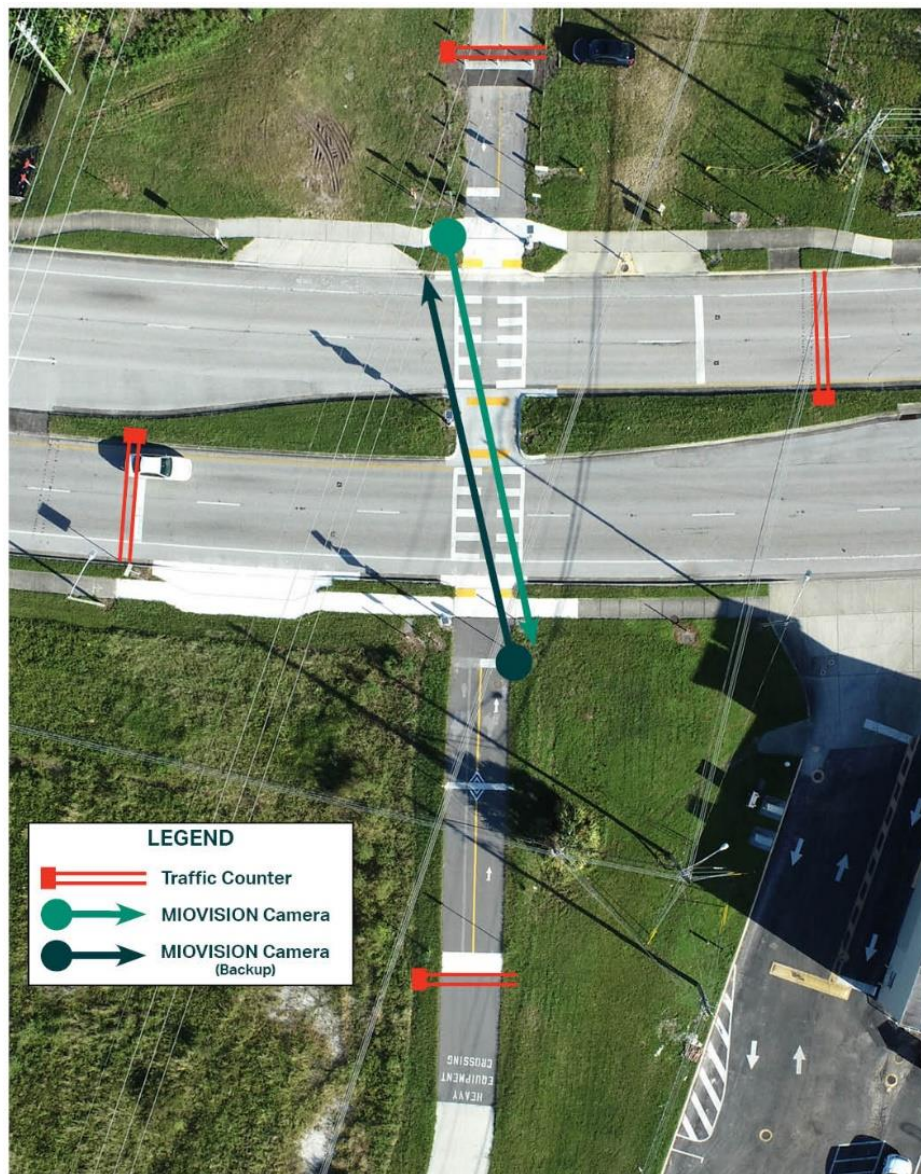
The project location map (**Figure 3-1**) depicts the location of the Pinellas Trail and Sunset Point Road crossing collected through drone footage in February 2022, after conditions, and illustrates the location of each piece of equipment.

**Figure 3-1: Pinellas Trail and Sunset Point Road Equipment Placement – After Conditions, February 2022**

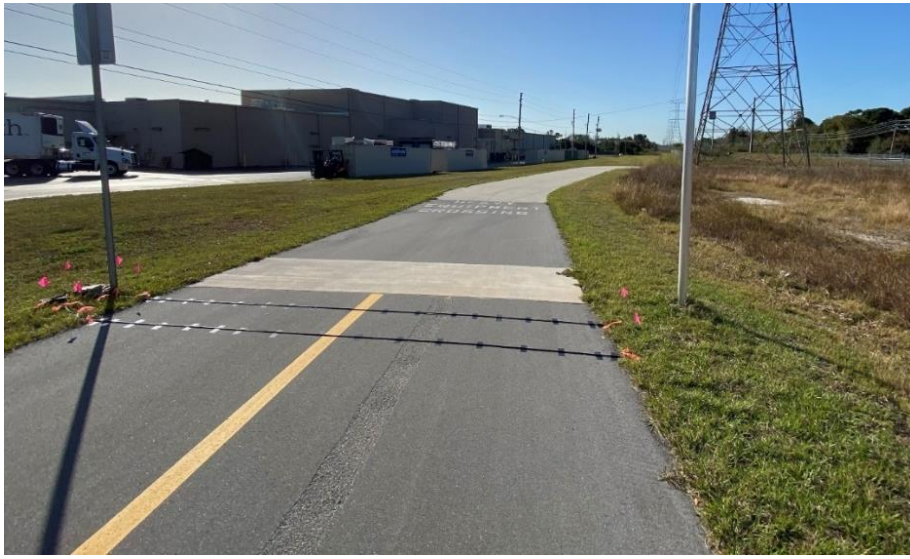
Pneumatic counters were installed on the north and the south sides of the Pinellas Trail and on Sunset Point Road (east and west) for the 4-day data collection period of February 17 to 20, 2022. **Figures 3-2 and 3-3** illustrate an example of the location of the pneumatic counters and the counting box equipment on the Pinellas Trail and on Sunset Point Road.

**Figure 3-2: Pneumatic Counters on the Pinellas Trail and Sunset Point Road On Sunset Trail both NB and SB**

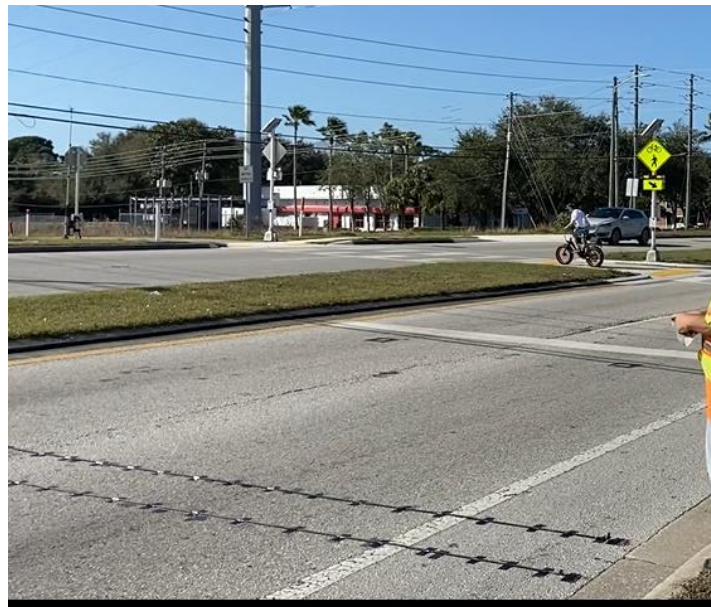
**Figure 3-3: Pneumatic Counters on the Pinellas Trail and Sunset Point Road On Sunset Point Road both EB and WB**

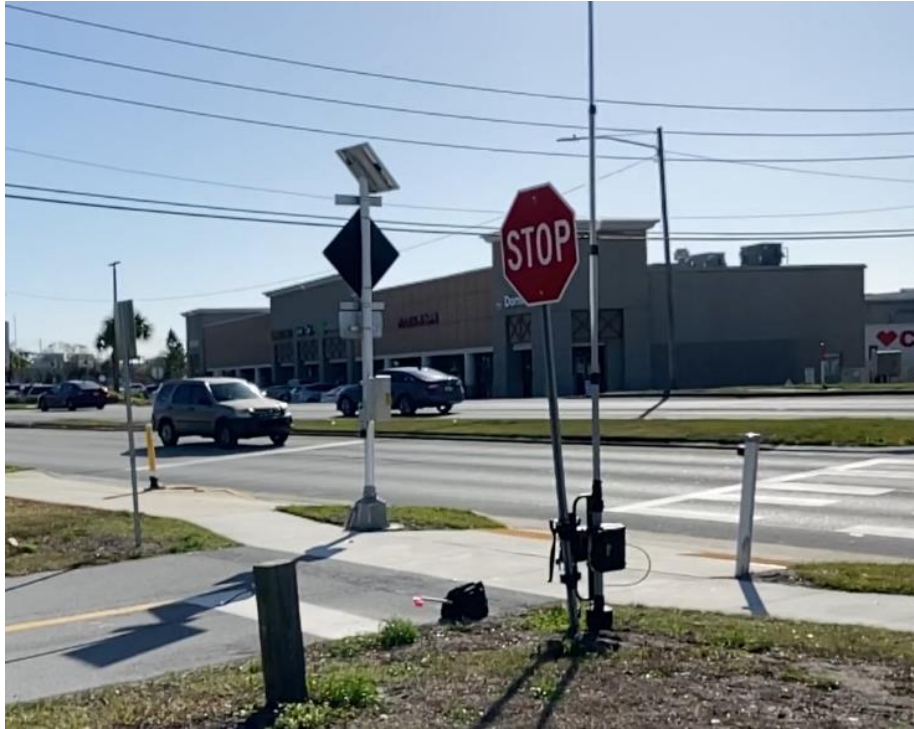
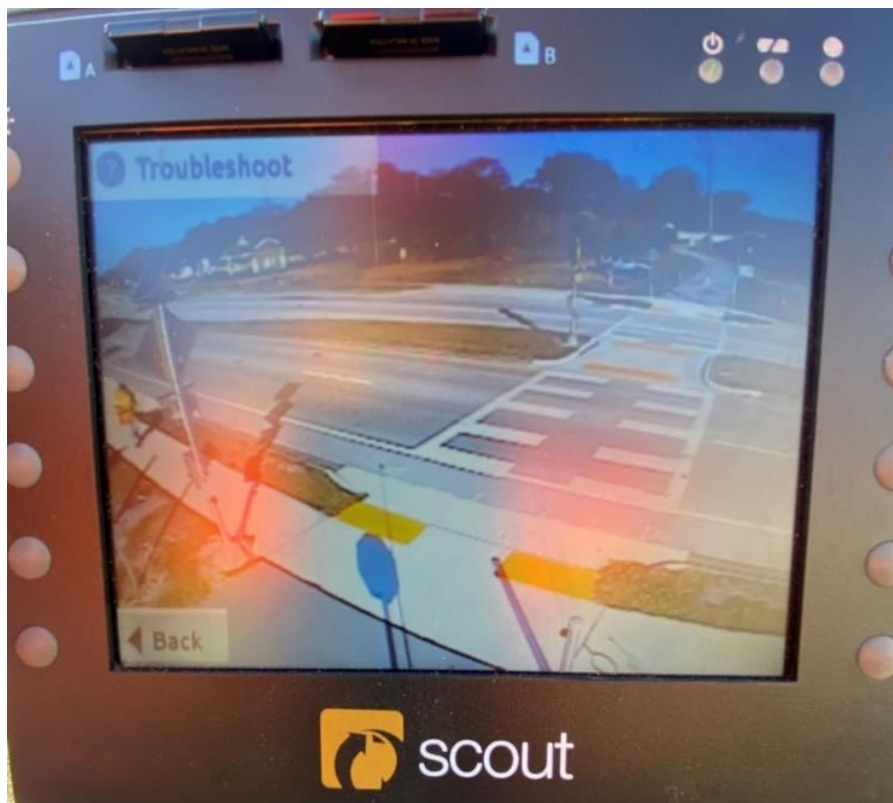
Two MioVision cameras were installed on the north and south sections of the Pinellas Trail and Sunset Point Road. **Figure 3-4** illustrates an example of the MioVision camera placement.

**Figure 3-4: MioVision Camera on the Pinellas Trail at Sunset Point Road**

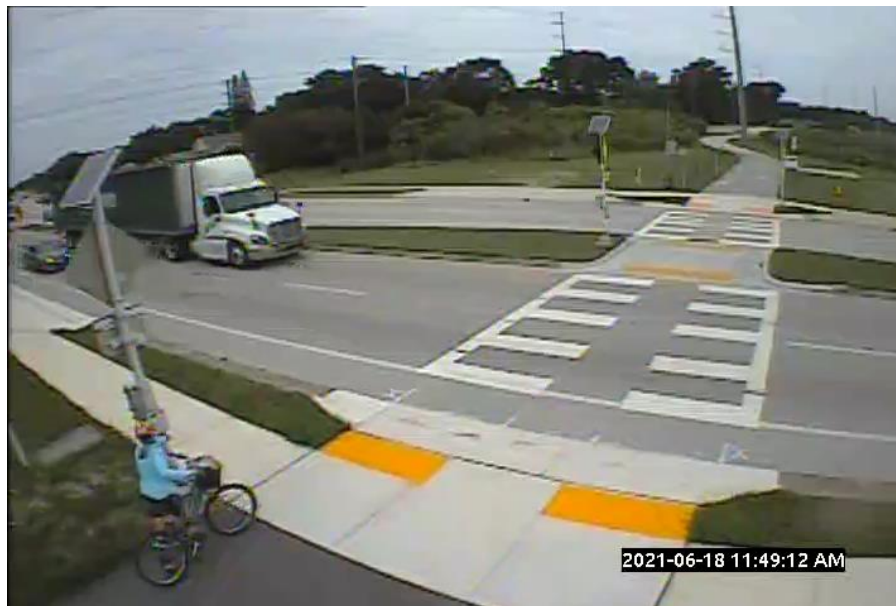
Scene 1: The bicyclist has activated the RRFBs crossing south to north.

**Figure 4-1 Bicyclist Crossing - No Yield Example Scene 1**

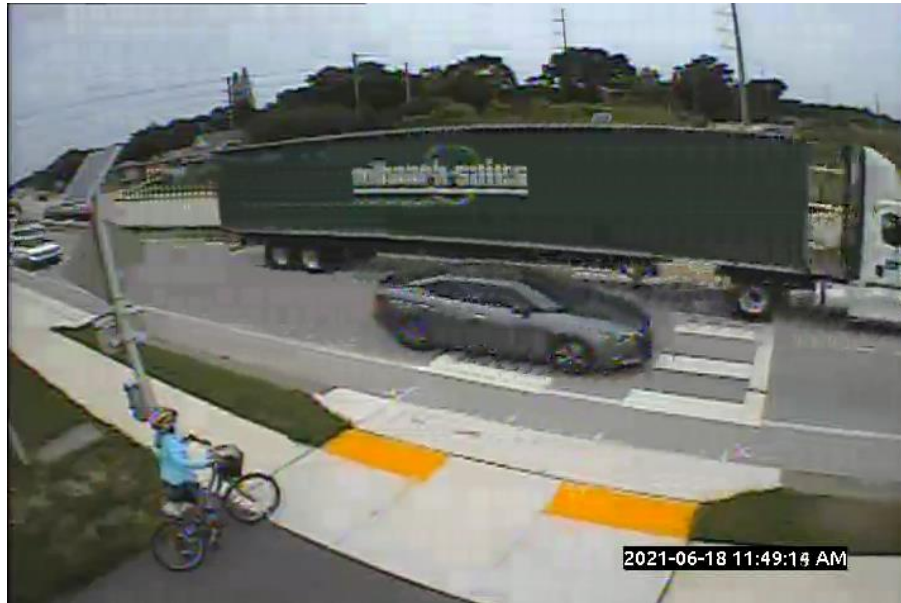
Scene 2: Two vehicles not counted, too close to stop within 3 to 5 seconds of activation

**Figure 4-2 Bicyclist Crossing No Yield Example Scene 2**

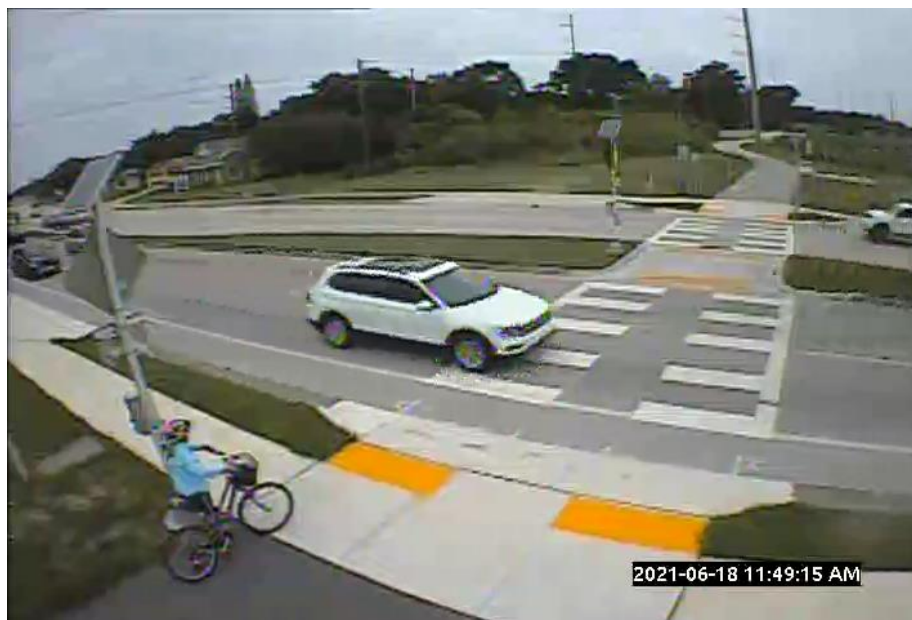
Scene 3: White SUV fails to yield in lane 4 EB, not counted as only 4 seconds passed.

**Figure 4-3 Bicyclist Crossing No Yield Example Scene 3**

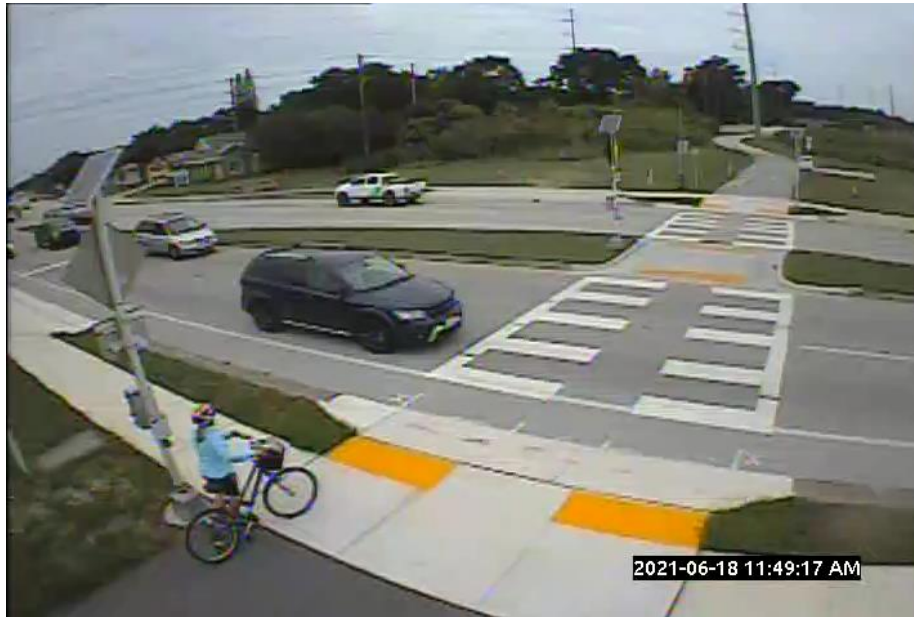
Scene 4: Black SUV is not slowing in lane 4 WB, approximately 5 to 6 seconds passed with active RRFBs. Counted as no yield.

**Figure 4-4 Bicyclist Crossing No Yield Example Scene 4**

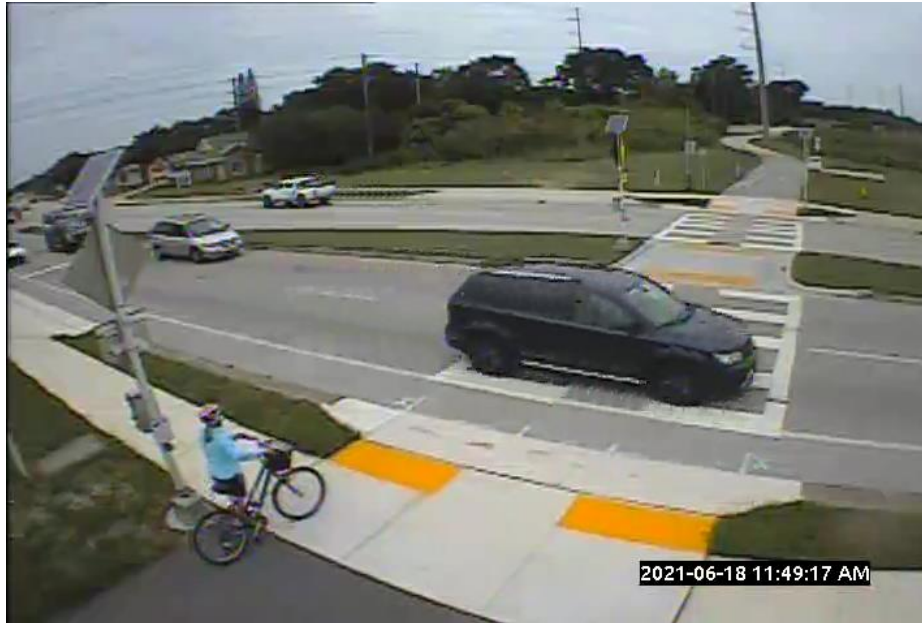
Scene 5: Black SUV fails to yield and continues through crosswalk, clearly not aware of cyclist.

**Figure 4-5 Bicyclist Crossing No Yield Example Scene 5**

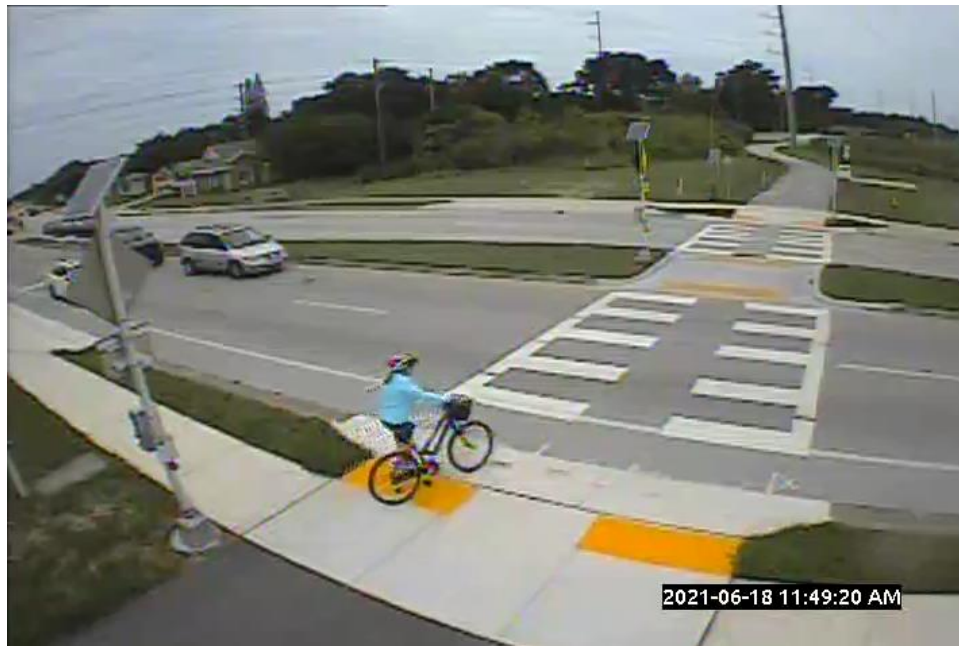
Scene 6: Three vehicles yield (lanes 3 and 4 EB), 8 seconds passed – counted as yields.

**Figure 4-6 Bicyclist Crossing No Yield Example Scene 6**

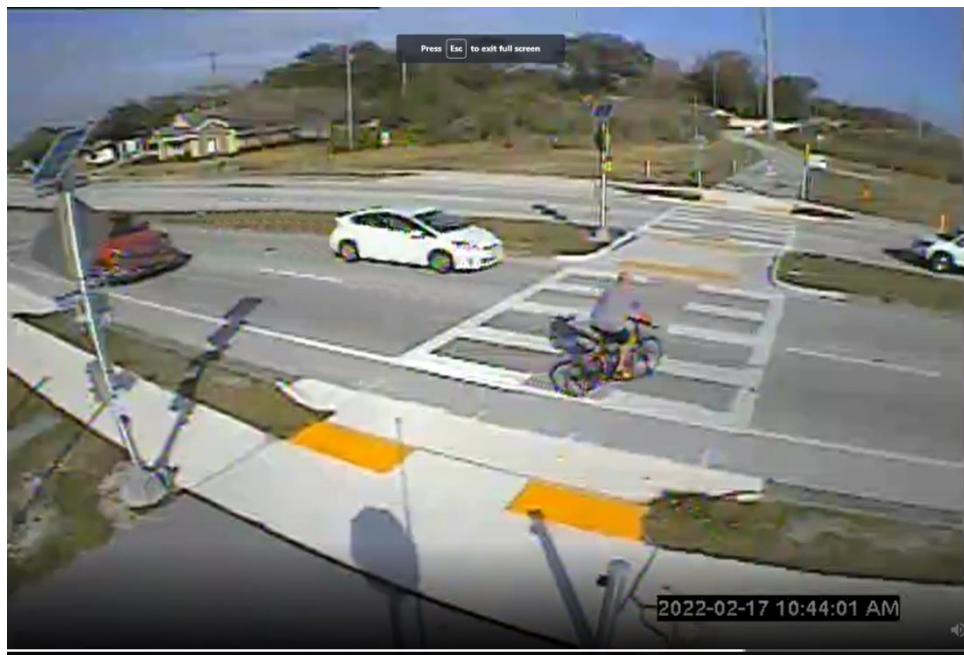
**Figure 4-7 Bicycle North Bound, No Yield, White Car EB Lane**

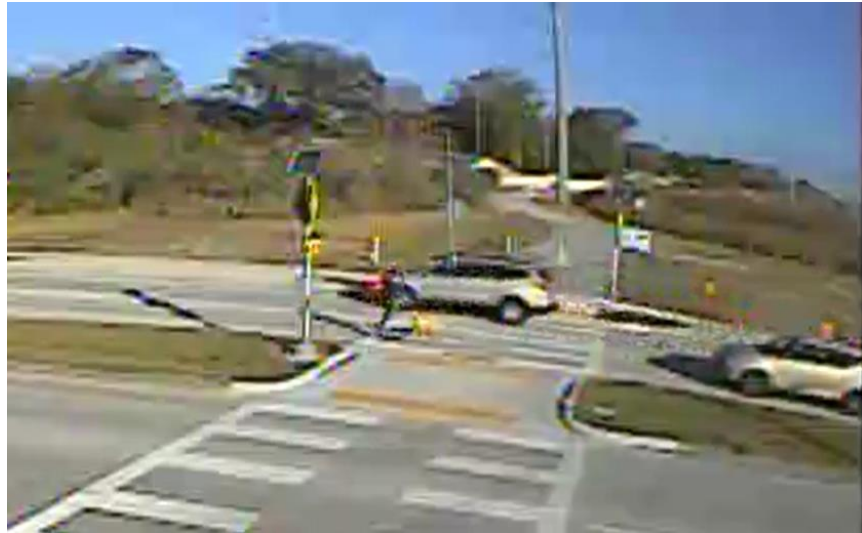
**Figure 4-8 Example of Skateboarder with Dog on Leash North Bound**

No Yield Grey Car WB – RRFB's Activated and Other Car Stopped

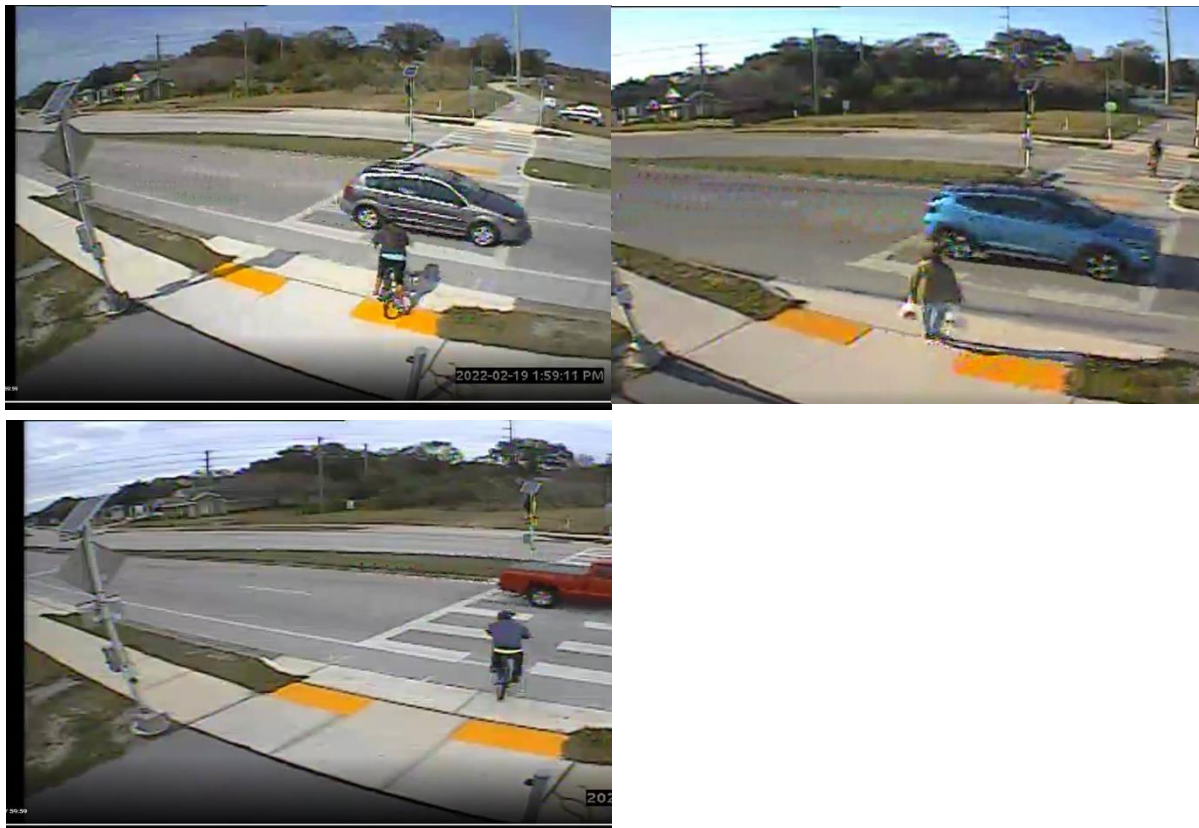
**Figure 4-9 Examples of Cyclists and Pedestrians Waiting at Least 6 Seconds with RRFBs Activated**

Distracted Drivers Fail to Yield.

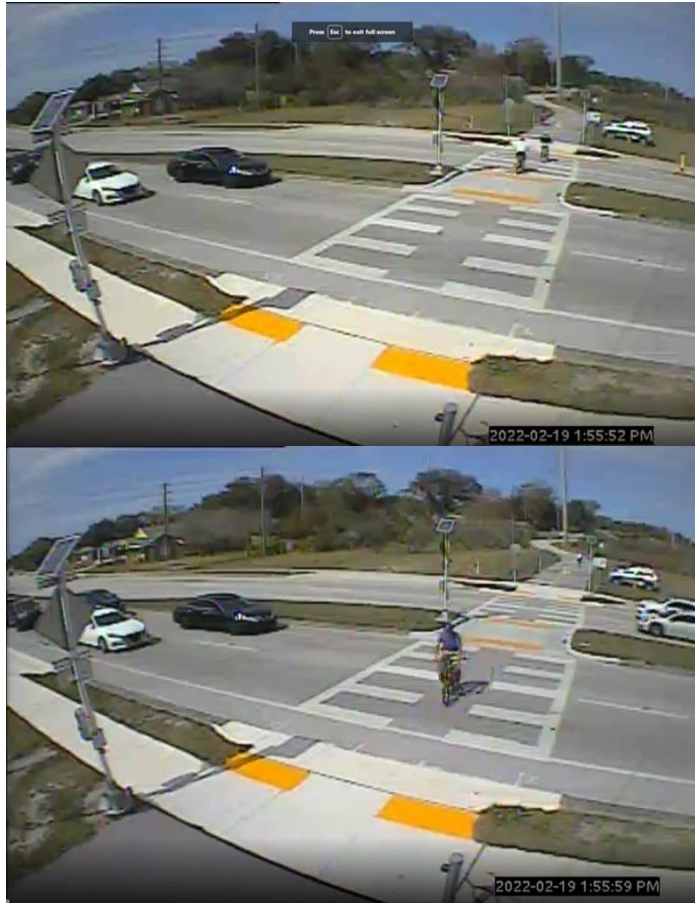
**Figure 4-10 Example of Two Separate Crossing Events Using All 40 Seconds on RRFBs.**

Two Riders north bound activate RRFBs, complete crossing. While RRFBs still flashing, another rider south bound does not slow down and crosses. Luckily stopped cars remained stopped. They must have seen second cyclist visually.

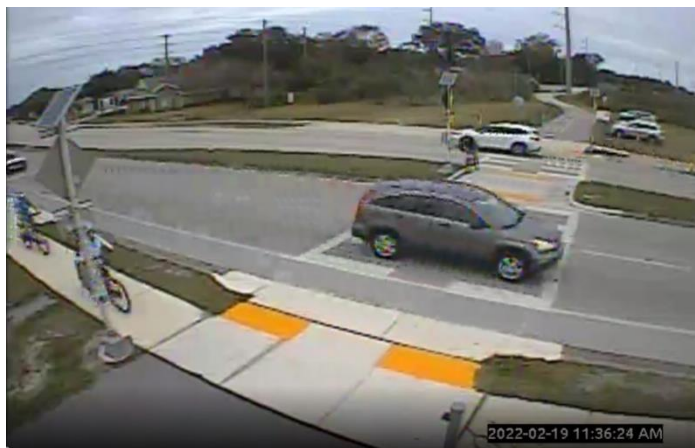
**Figure 4-11 Stuck in the Median, RRFBs Flashing, Cars in Both Directions No Yield in Both Directions**

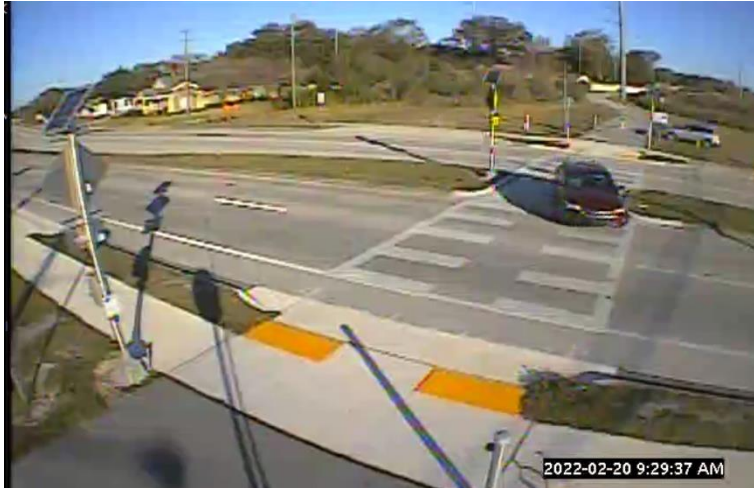
**Figure 4-12 Odd Behavior: U-Turn in Crossing, Sunday Morning**

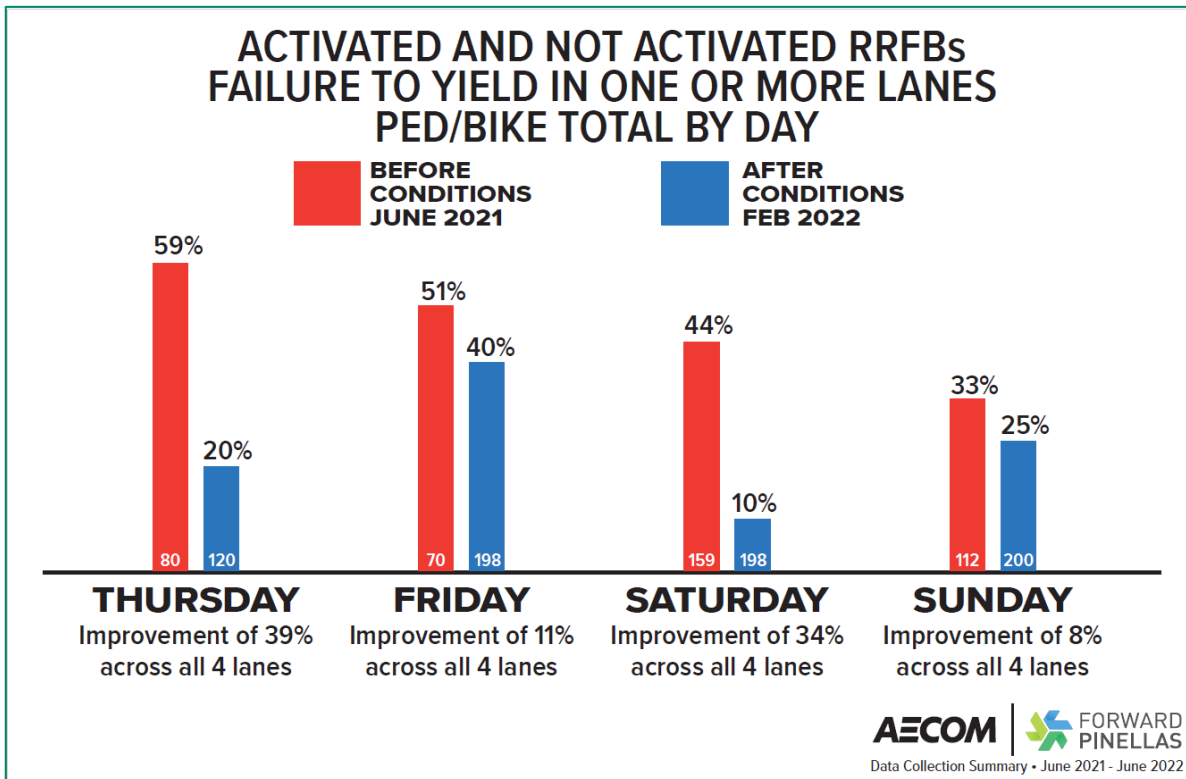
**Figure 4-13 Activated and Not Activated RRFBs Failure to Yield Total by Day**
