# Pinellas Trail and Sunset Point Road Crossing After Conditions Technical Memorandum

Prepared for:  
Forward Pinellas

Prepared by:  
AECOM  
7650 West Courtney Campbell Causeway

July 2022

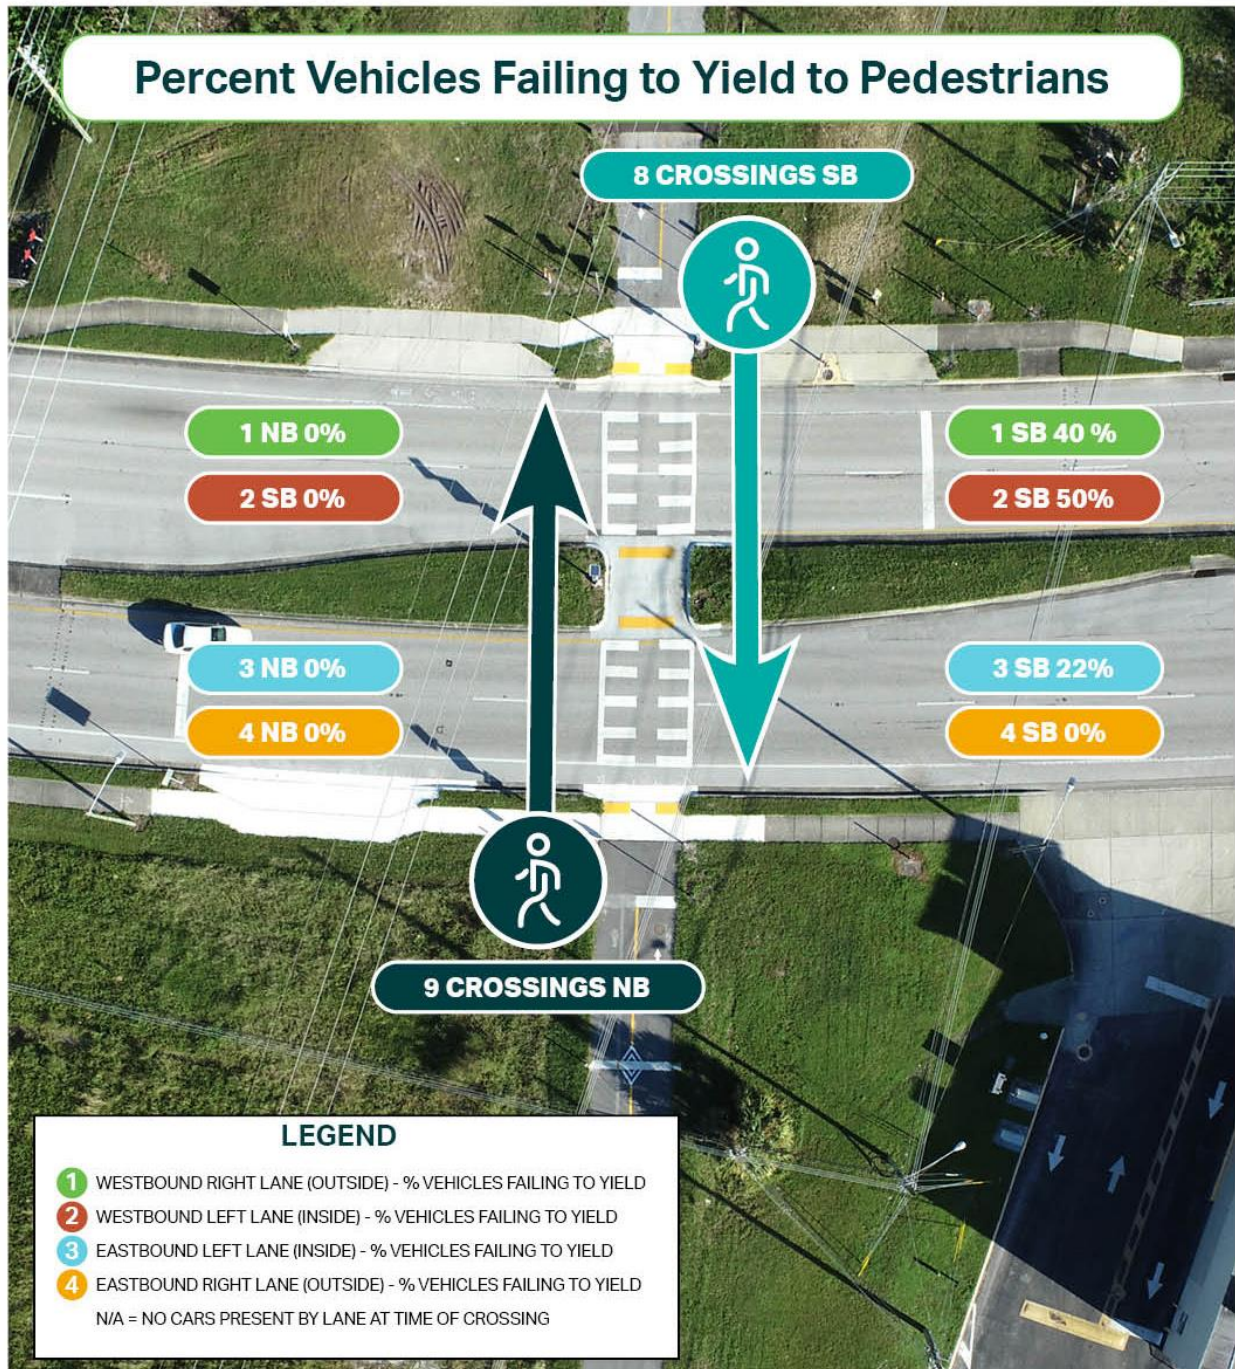
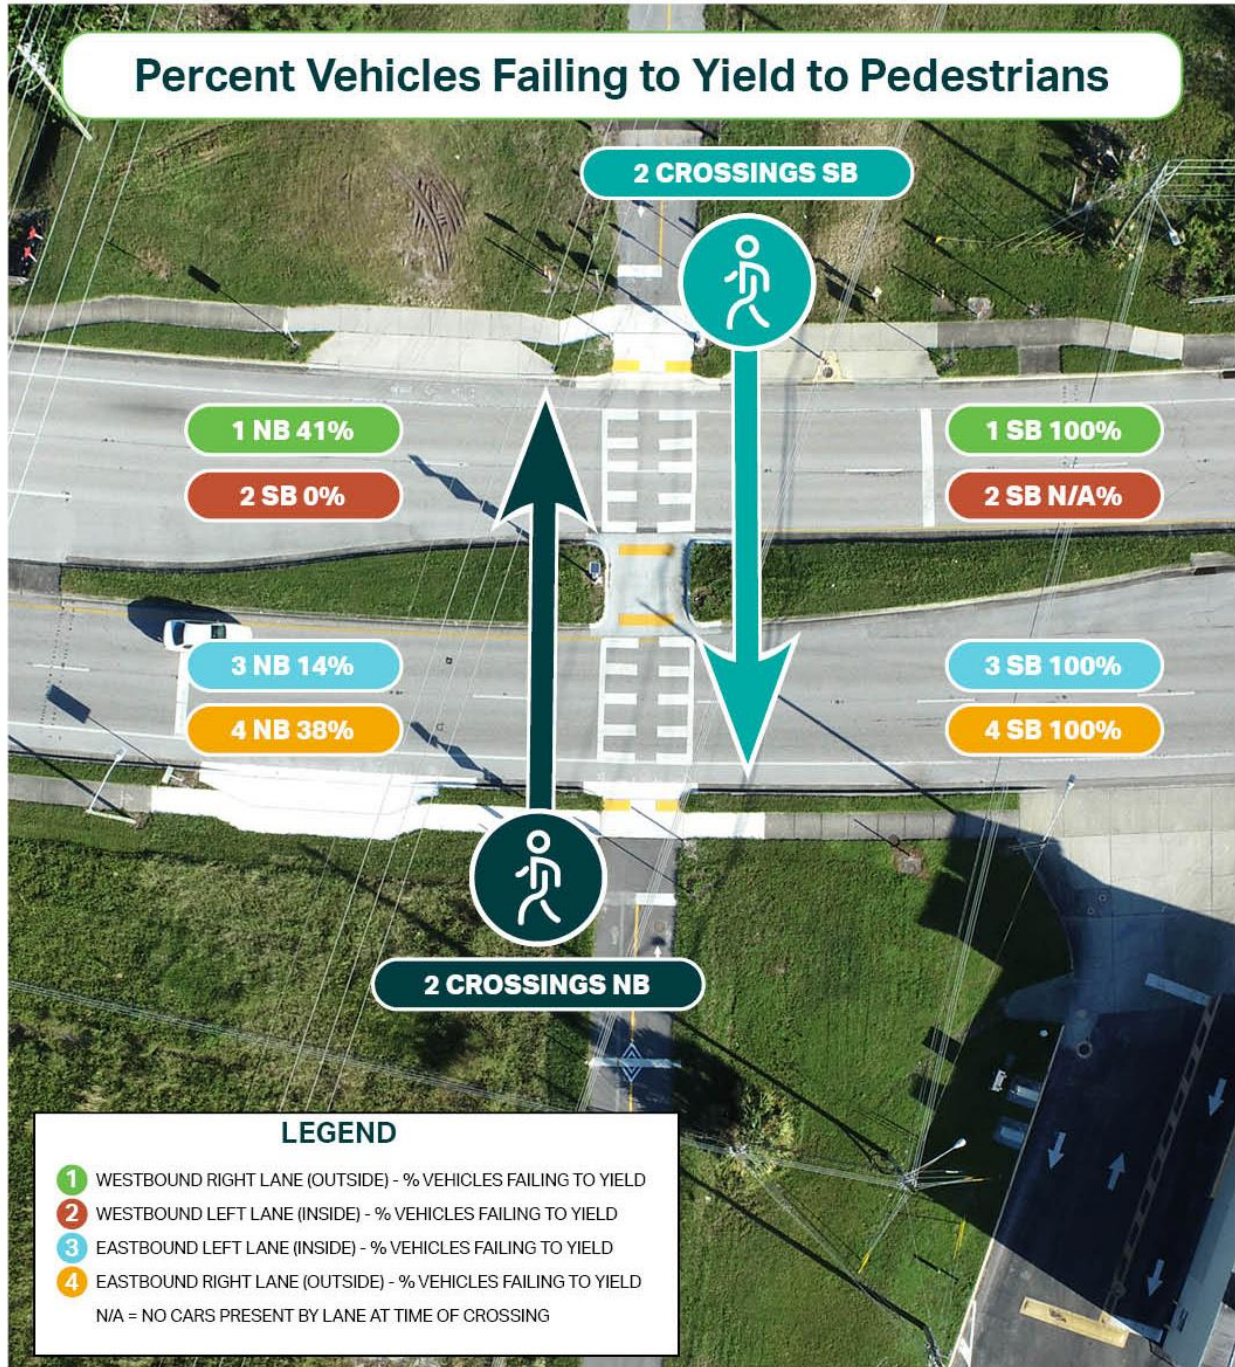
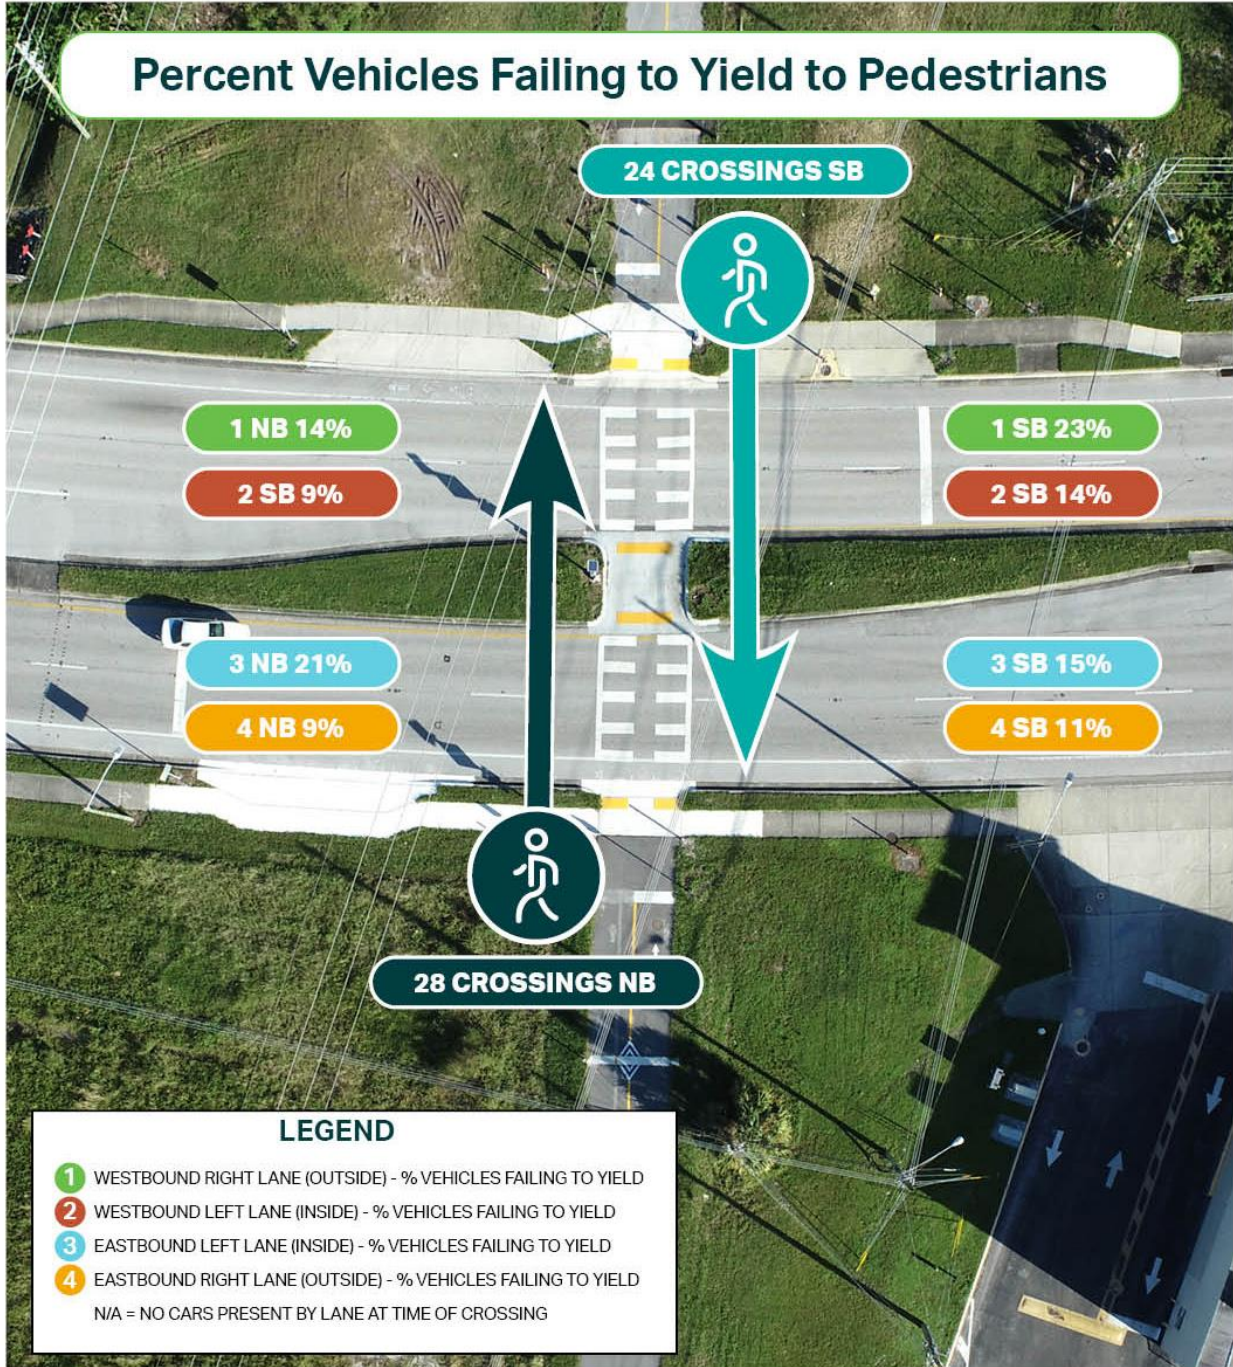
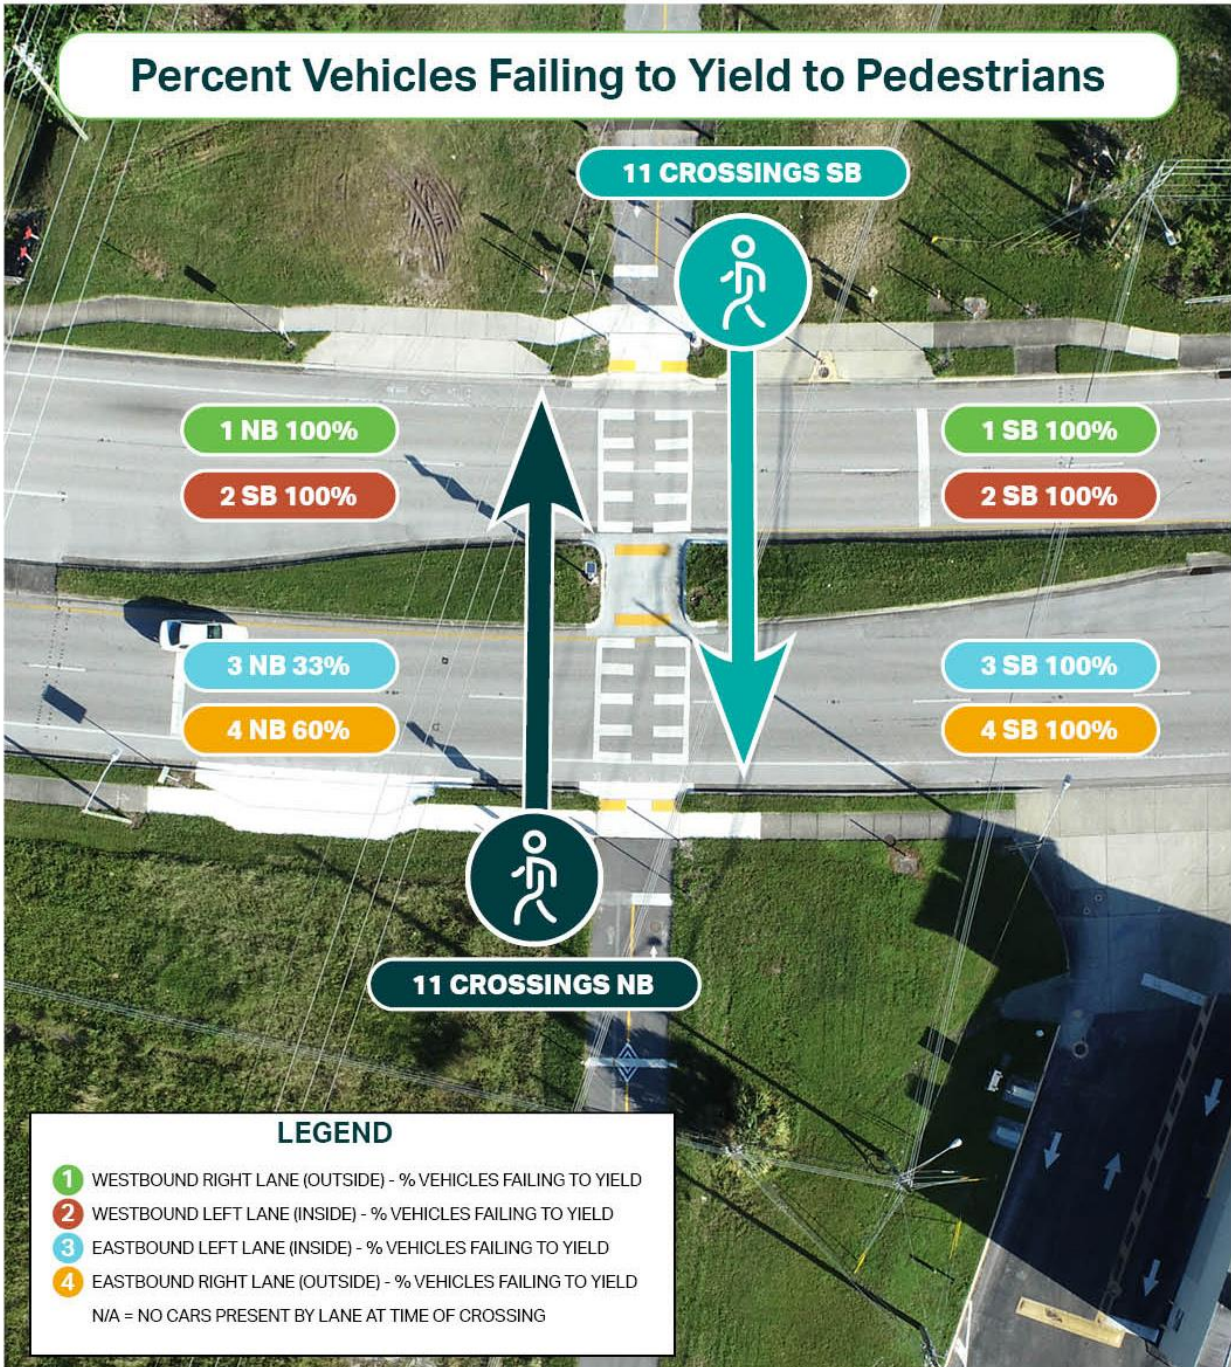
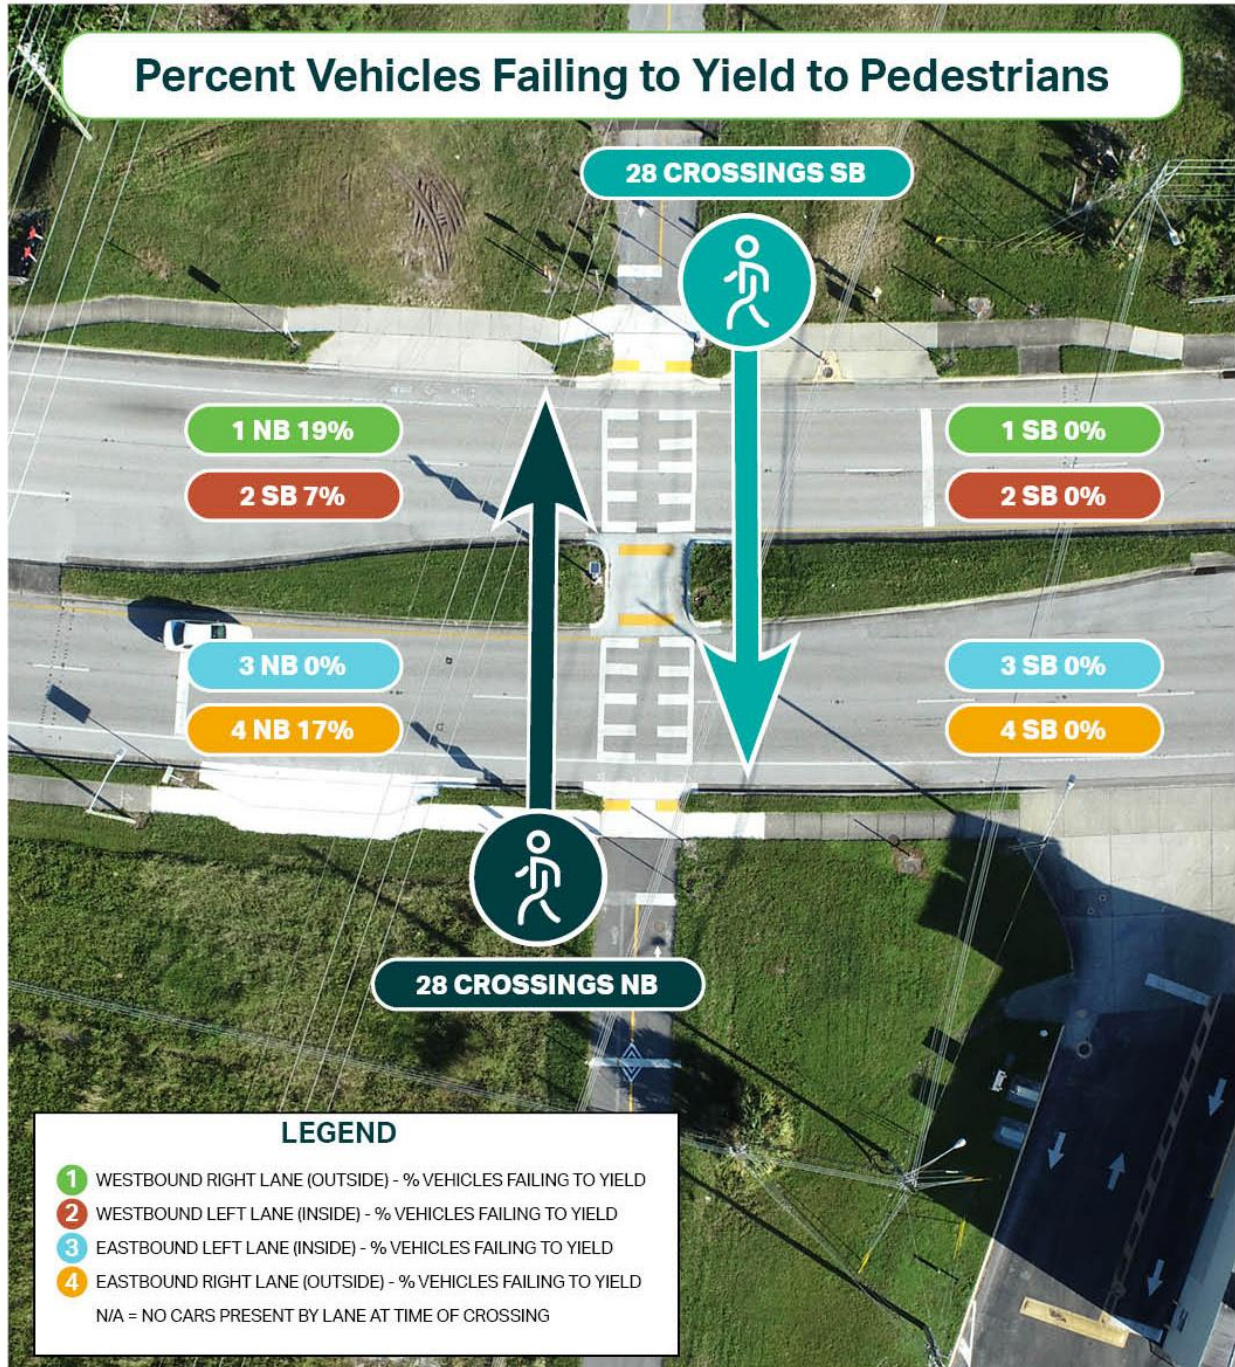
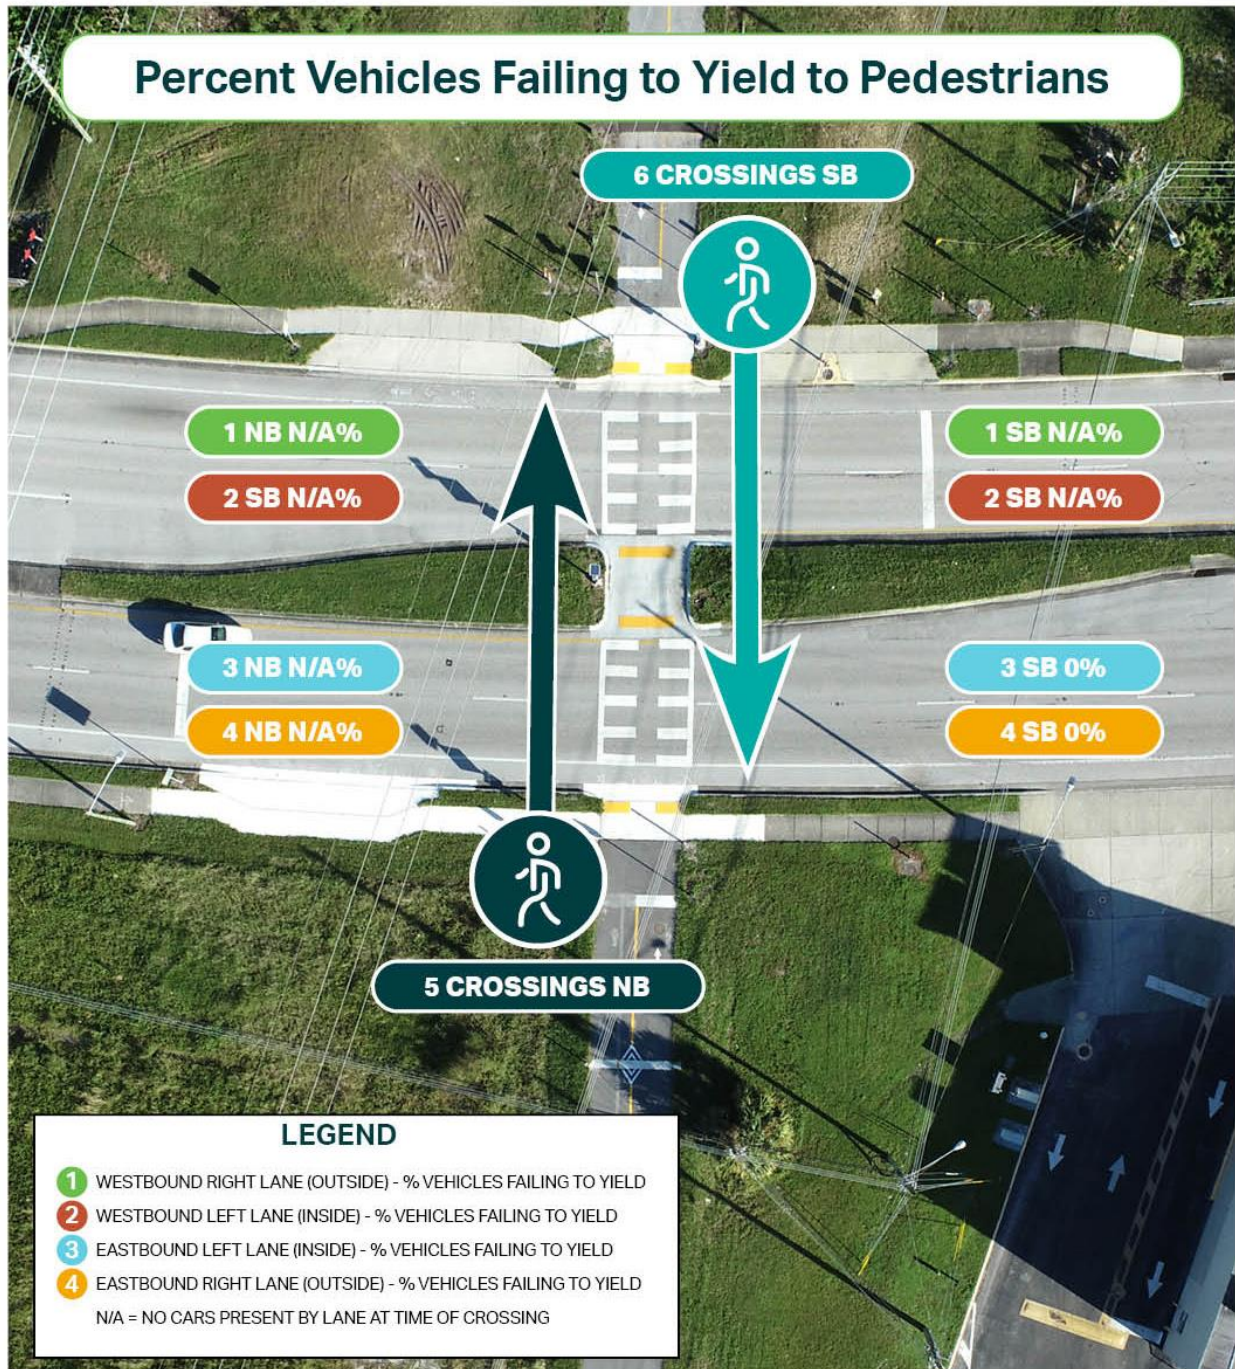
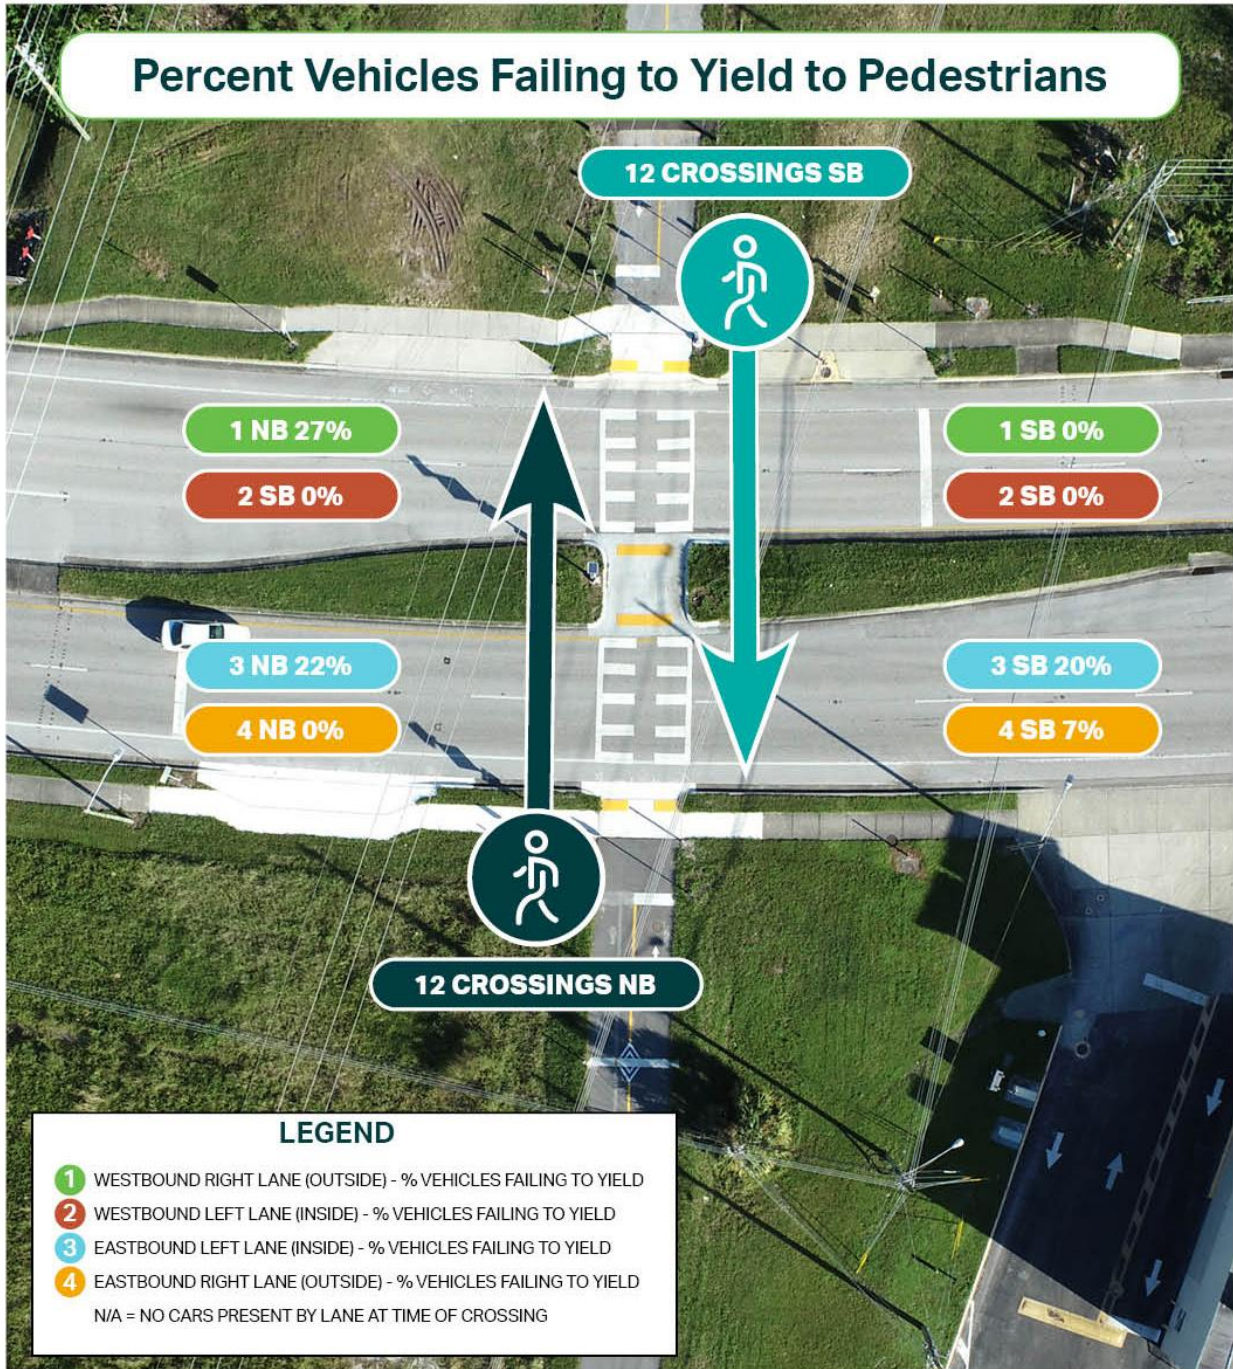
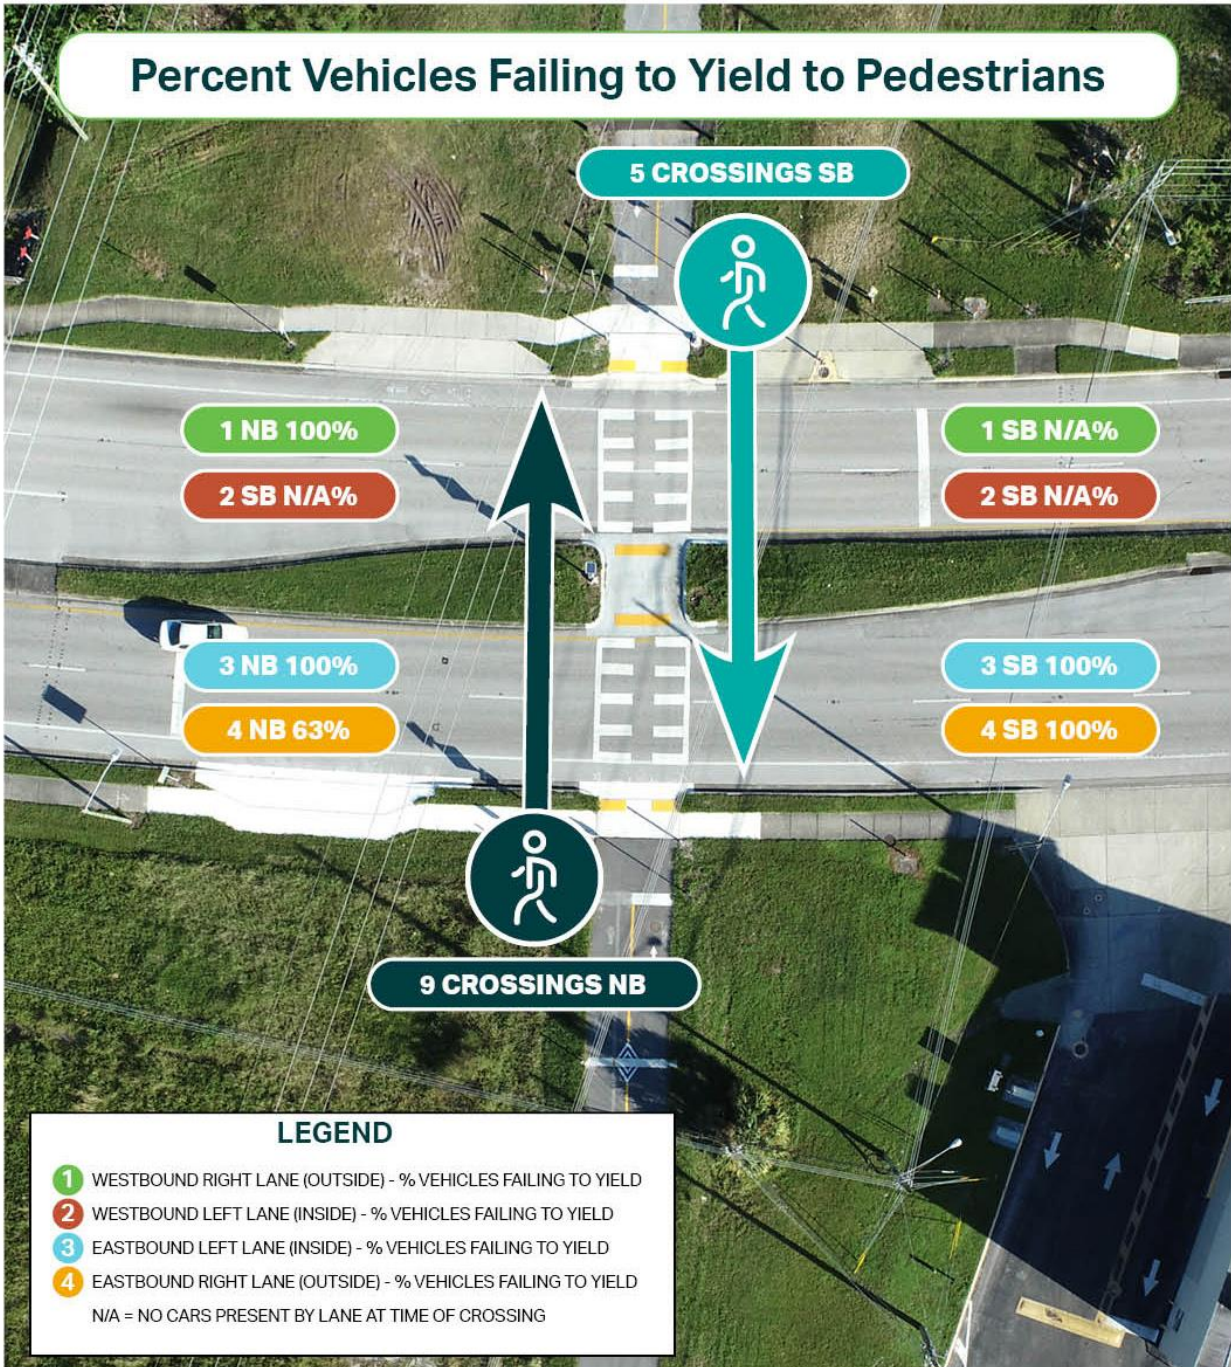
Figures 4-14 to 4-30 provide an illustration of the vehicle yield percentages by lane for pedestrians and bicyclists across all four days.

**Figure 4-14 Vehicles Not Yielding to Pedestrians – Button Activated – Feb 17**  
**Pinellas Trail and Sunset Point Road Crossing**  
**By Lane - Total for the Day of February 17, 2022**  
**(6:00 AM to 8:00 PM)**  
**Button Activated**

Figure 4-15 Vehicles Not Yielding to Pedestrians – Button Not Activated – Feb 17

Figure 4-16 Vehicles Not Yielding to Pedestrians – Button Activated – Feb 18  
**Pinellas Trail and Sunset Point Road Crossing**  
**By Lane - Total for the Day of February 18, 2022**  
 (6:00 AM to 8:00 PM)  
**Button Activated**

Figure 4-17 Vehicles Not Yielding to Pedestrians – Button Not Activated – Feb 18  
**Pinellas Trail and Sunset Point Road Crossing**  
**By Lane - Total for the Day of February 18, 2022**  
 (6:00 AM to 8:00 PM)

Figure 4-18 Vehicles Not Yielding to Pedestrians – Button Activated – Feb 19  
**Pinellas Trail and Sunset Point Road Crossing**  
**By Lane - Total for the Day of February 19, 2022**  
 (6:00 AM to 8:00 PM)  
**Button Activated**

Figure 4-19 Vehicles Not Yielding to Pedestrians – Button Not Activated – Feb 19  
**Pinellas Trail and Sunset Point Road Crossing**  
**By Lane - Total for the Day of February 19, 2022**  
 (6:00 AM to 8:00 PM)

Figure 4-20 Vehicles Not Yielding to Pedestrians – Button Activated – Feb 20  
**Pinellas Trail and Sunset Point Road Crossing**  
**By Lane - Total for the Day of February 20, 2022**  
 (6:00 AM to 8:00 PM)  
**Button Activated**

Figure 4-21 Vehicles Not Yielding to Pedestrians – Button Not Activated – Feb 20  
**Pinellas Trail and Sunset Point Road Crossing**  
**By Lane - Total for the Day of February 20, 2022**  
 (6:00 AM to 8:00 PM)
