# Pinellas Trail and Sunset Point Road Crossing After Conditions Technical Memorandum

Prepared for:  
Forward Pinellas

Prepared by:  
AECOM  
7650 West Courtney Campbell Causeway

July 2022

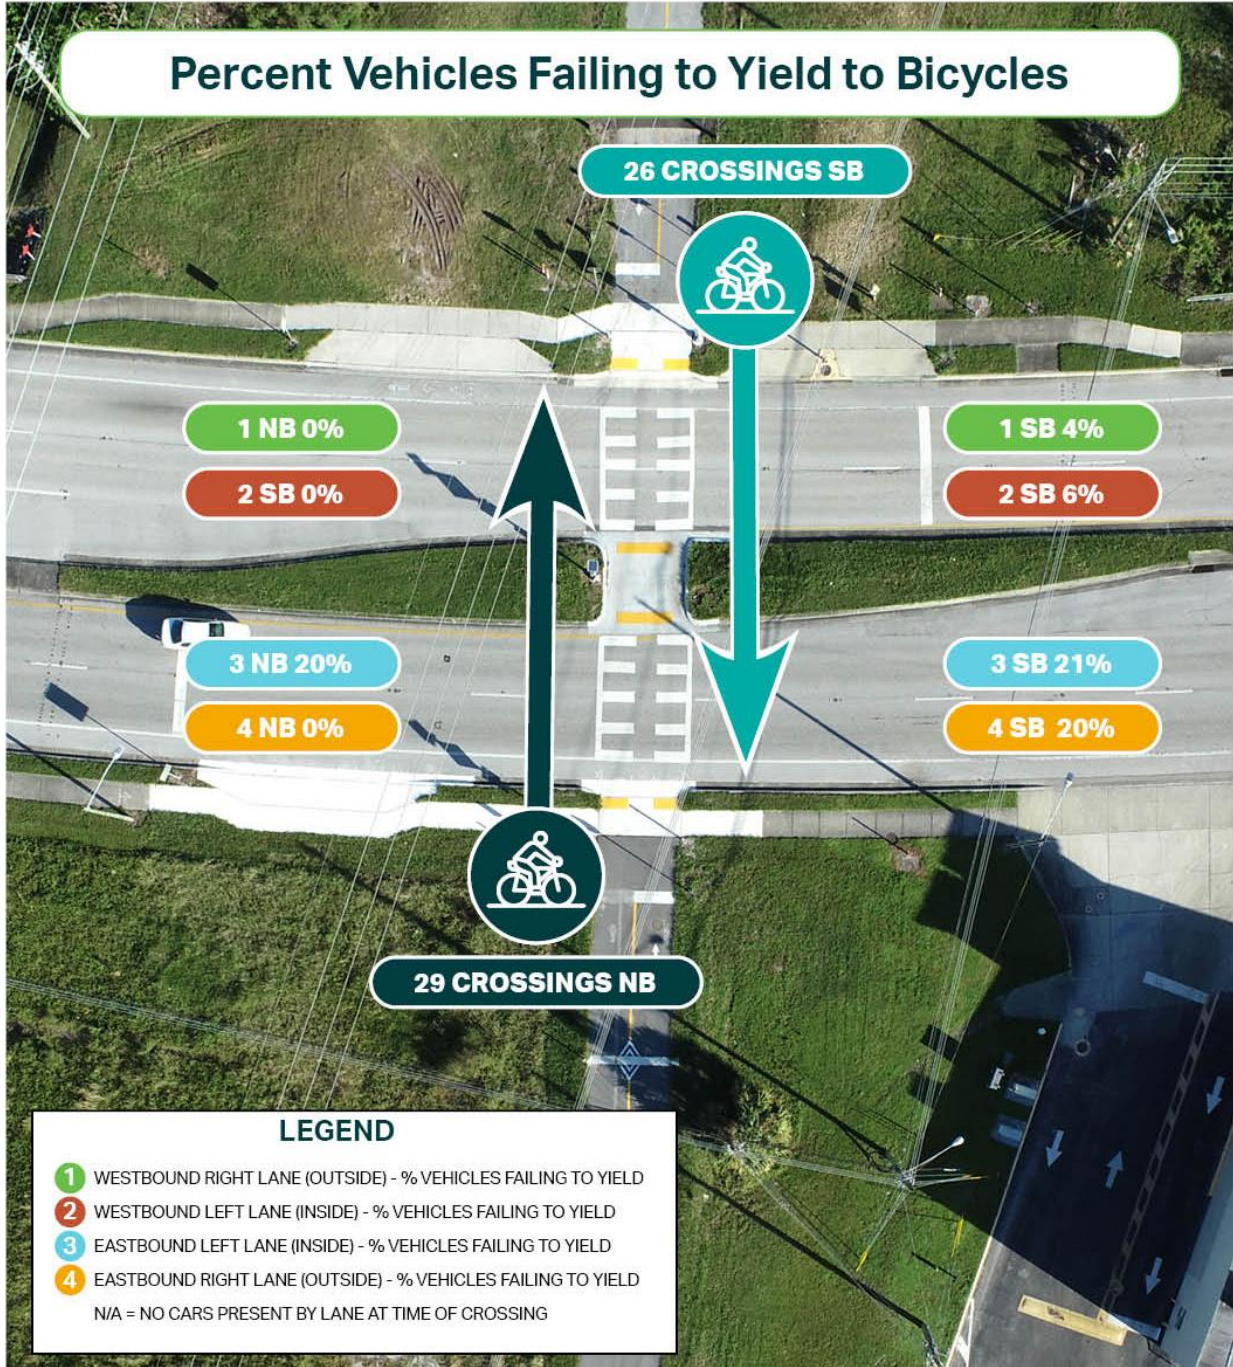
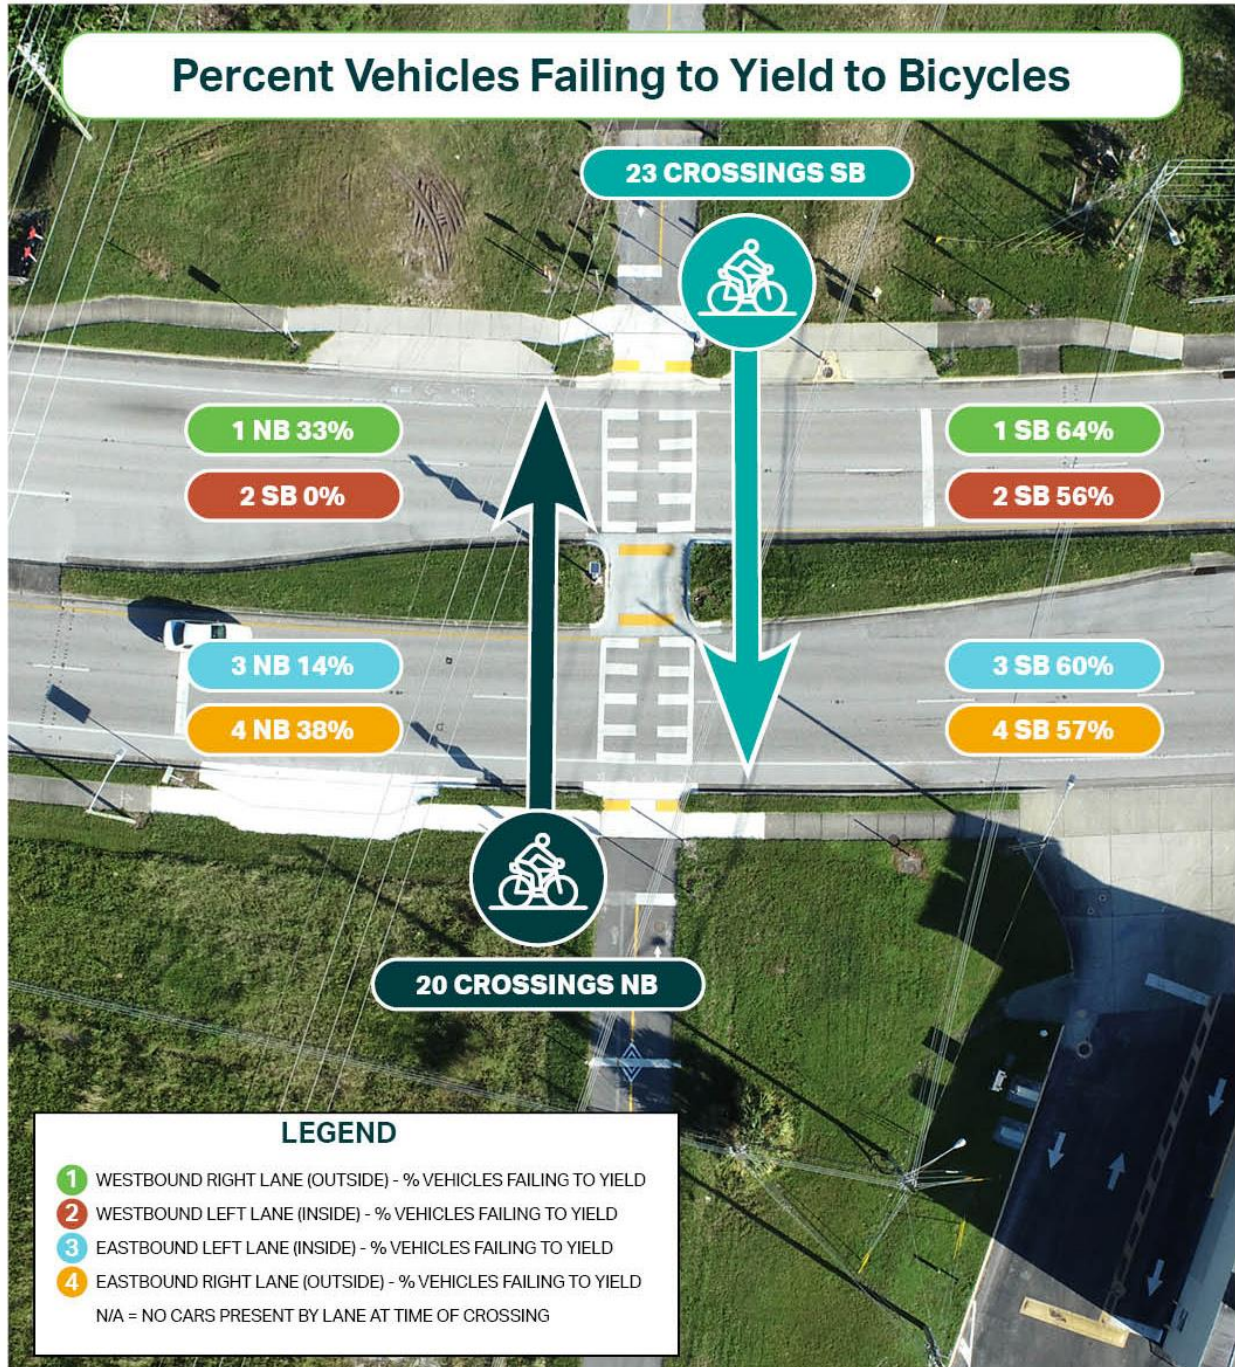
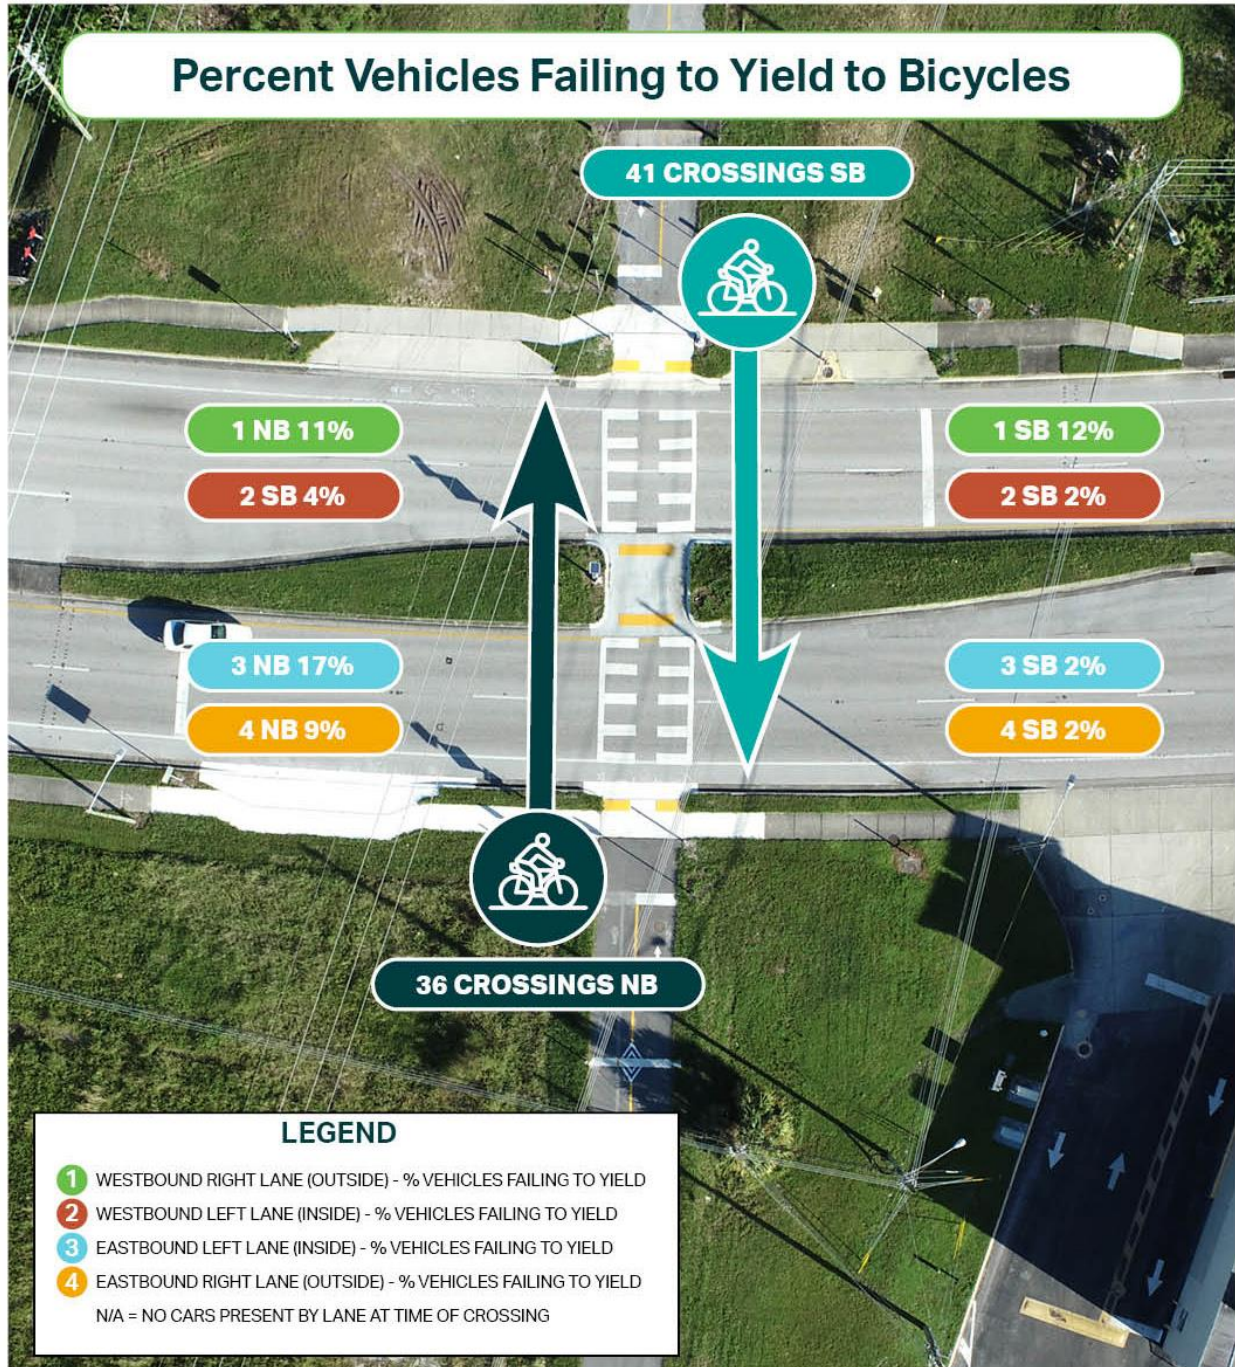
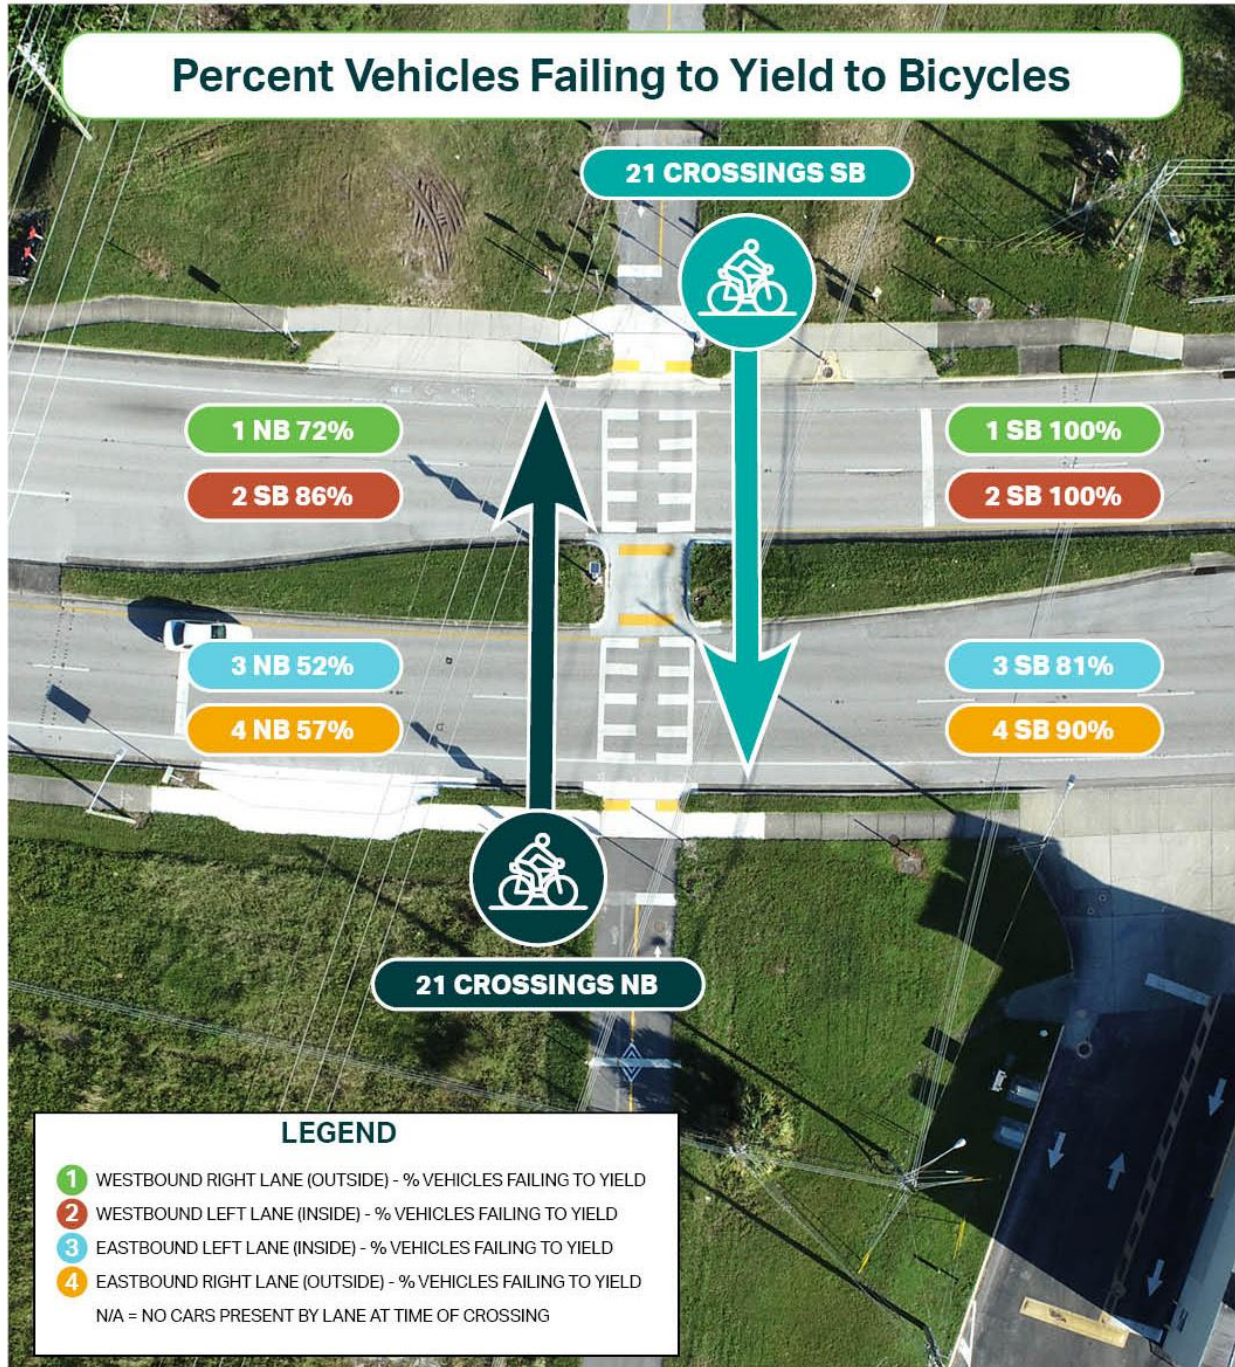
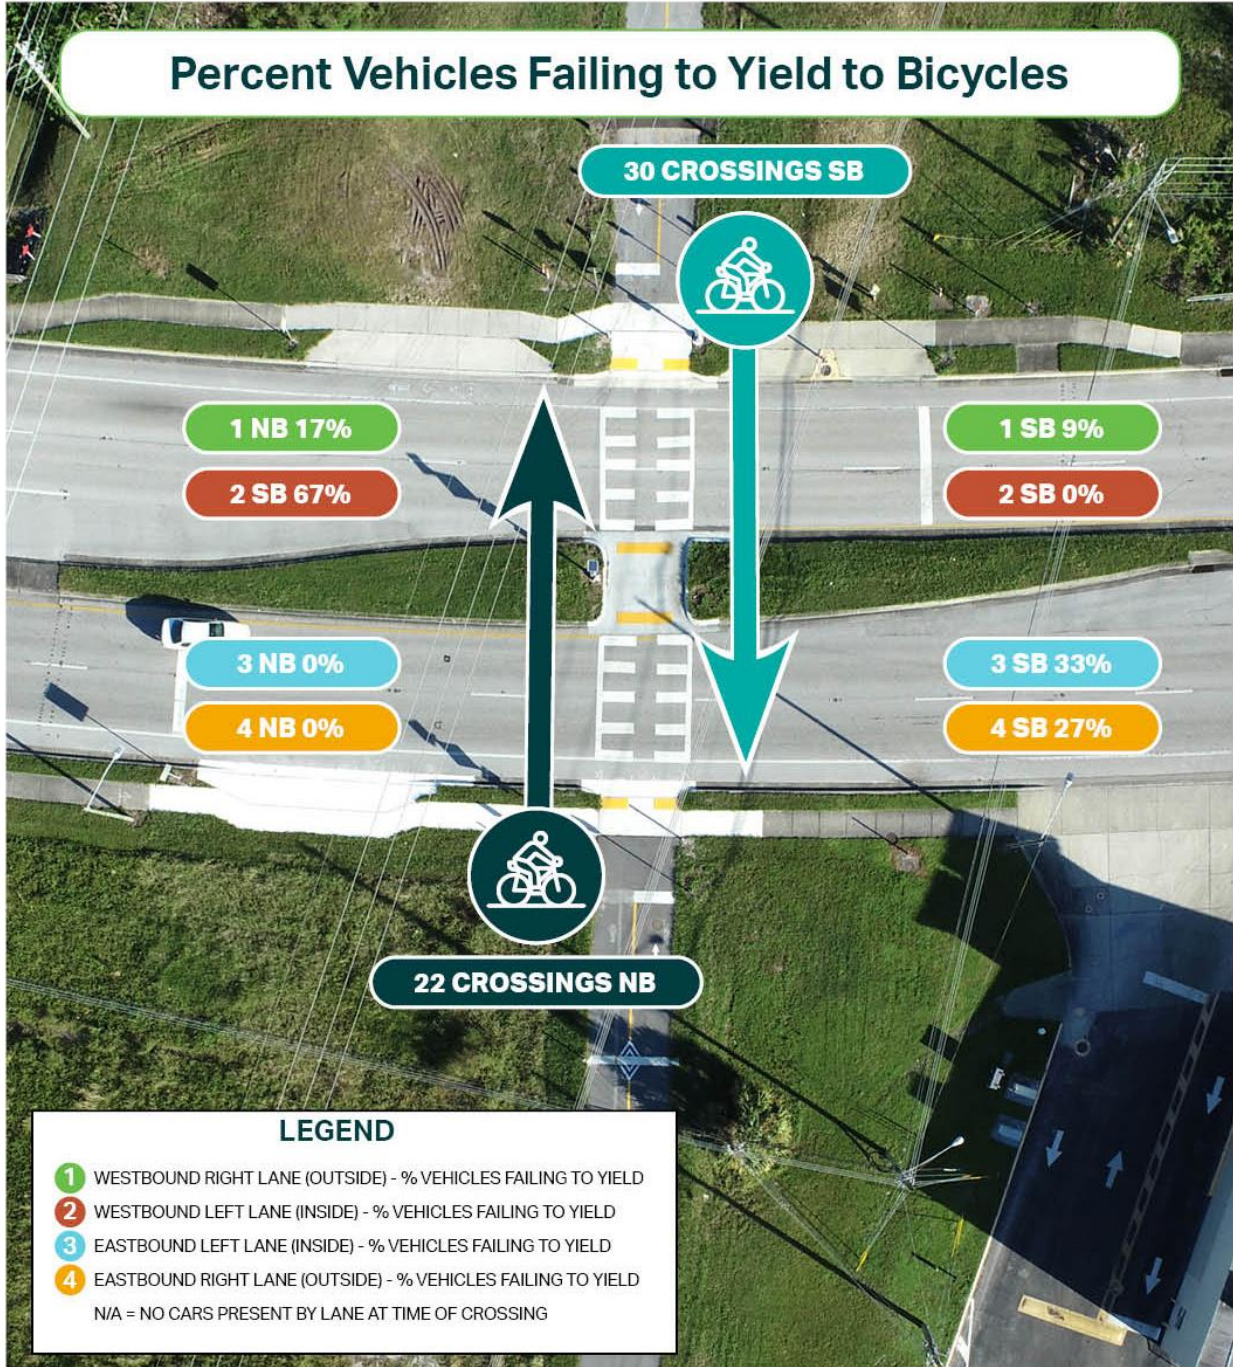
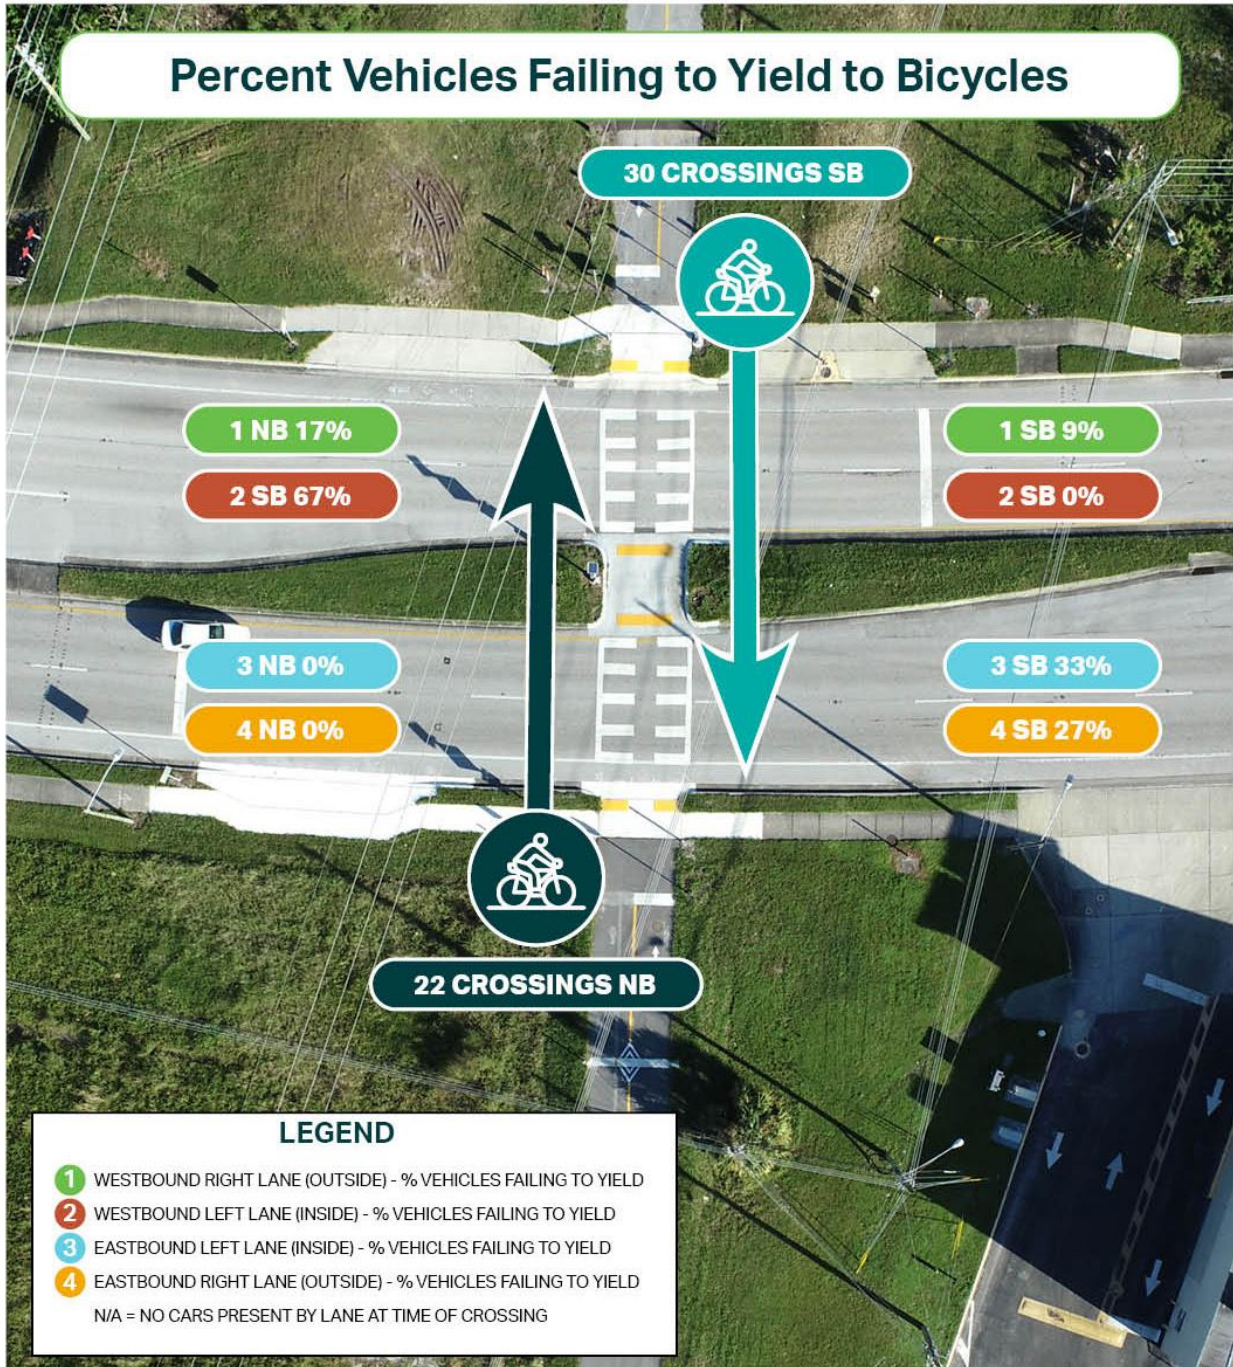
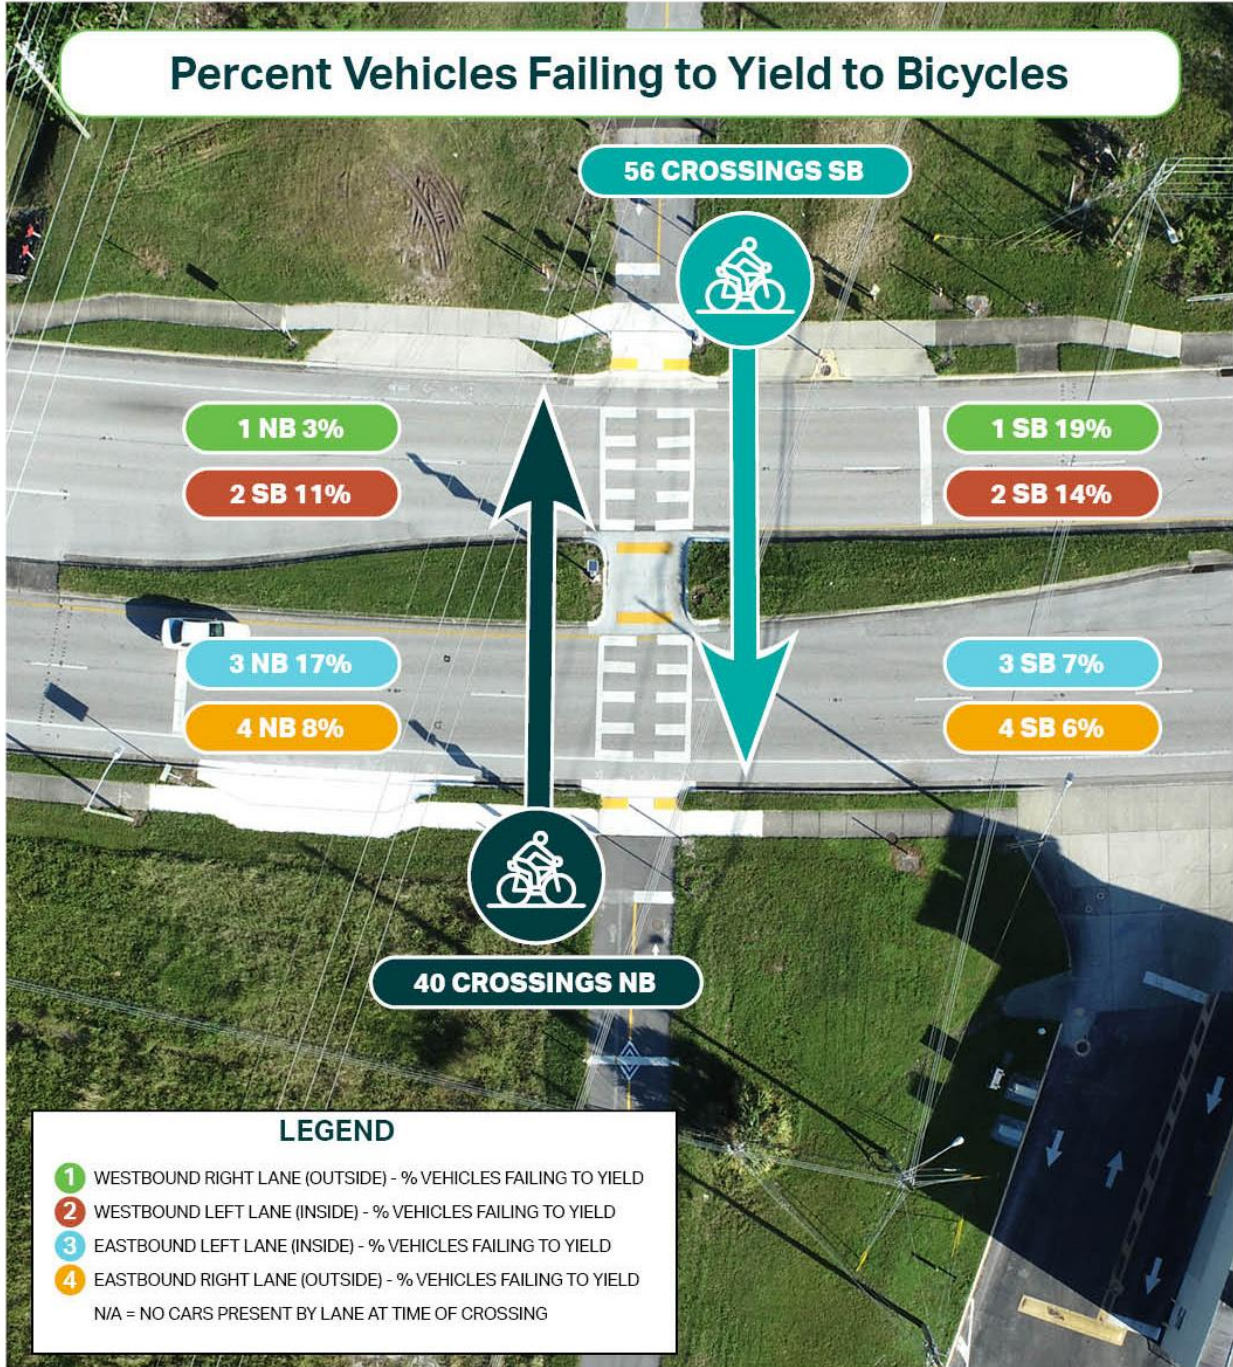
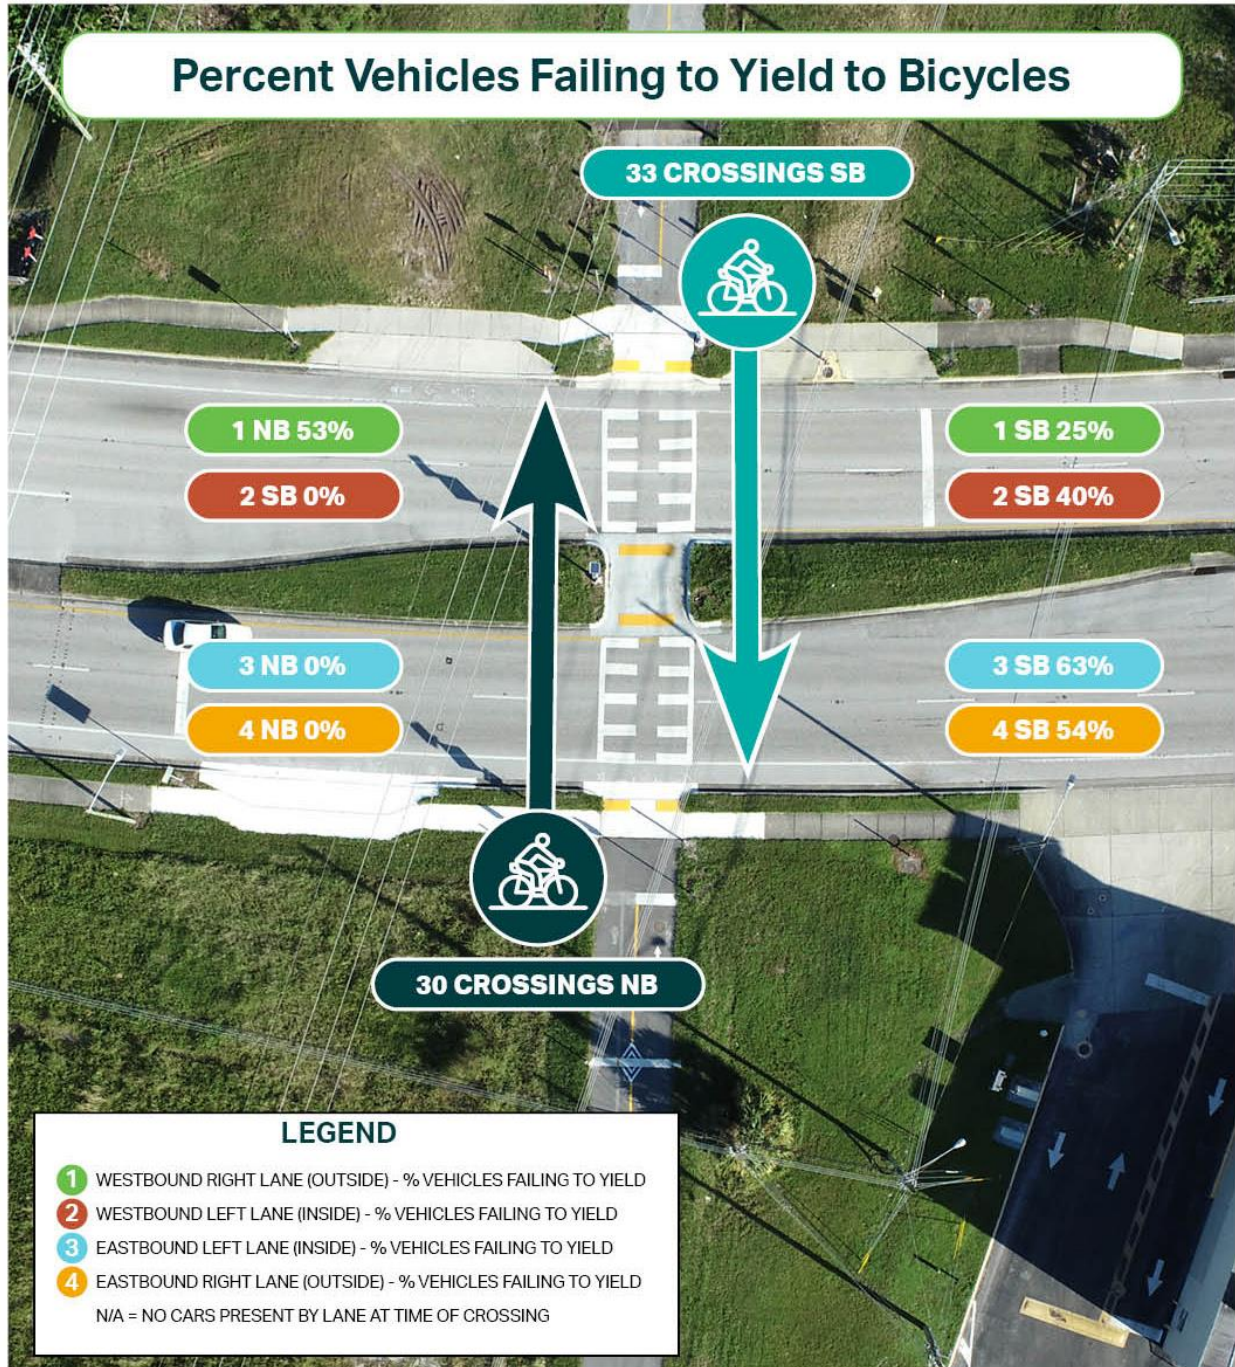
Figure 4-22 Vehicles Not Yielding to Bicycles – Button Activated – Feb 17

Figure 4-23 Vehicles Not Yielding to Bicycles – Button Not Activated – Feb 17  
**Pinellas Trail and Sunset Point Road Crossing**  
**By Lane - Total for the Day of February 17, 2022**  
 (6:00 AM to 8:00 PM)

Figure 4-24 Vehicles Not Yielding to Bicycles – Button Activated – Feb 18

Figure 4-25 Vehicles Not Yielding to Bicycles – Button Not Activated – Feb 18  
**Pinellas Trail and Sunset Point Road Crossing**  
**By Lane - Total for the Day of February 18, 2022**  
 (6:00 AM to 8:00 PM)

Figure 4-26 Vehicles Not Yielding to Bicycles – Button Activated – Feb 19  
**Pinellas Trail and Sunset Point Road Crossing**  
**By Lane - Total for the Day of February 19, 2022**  
 (6:00 AM to 8:00 PM)  
**Button Activated**

Figure 4-27 Vehicles Not Yielding to Bicycles – Button Not Activated – Feb 19  
**Pinellas Trail and Sunset Point Road Crossing**  
**By Lane - Total for the Day of February 19, 2022**  
 (6:00 AM to 8:00 PM)

Figure 4-29 Vehicles Not Yielding to Bicycles – Button Activated – Feb 20

Figure 4-30 Vehicles Not Yielding to Bicycles – Button Not Activated – Feb 20  
**Pinellas Trail and Sunset Point Road Crossing**  
**By Lane - Total for the Day of February 20, 2022**  
 (6:00 AM to 8:00 PM)
