Demonstration Project Planning

**Subject: Safe Streets Pinellas
Nursery Road/Duke Energy Trail Demonstration Summary**

Subject: Safe Streets Pinellas Nursery Road Demonstration Project Concept

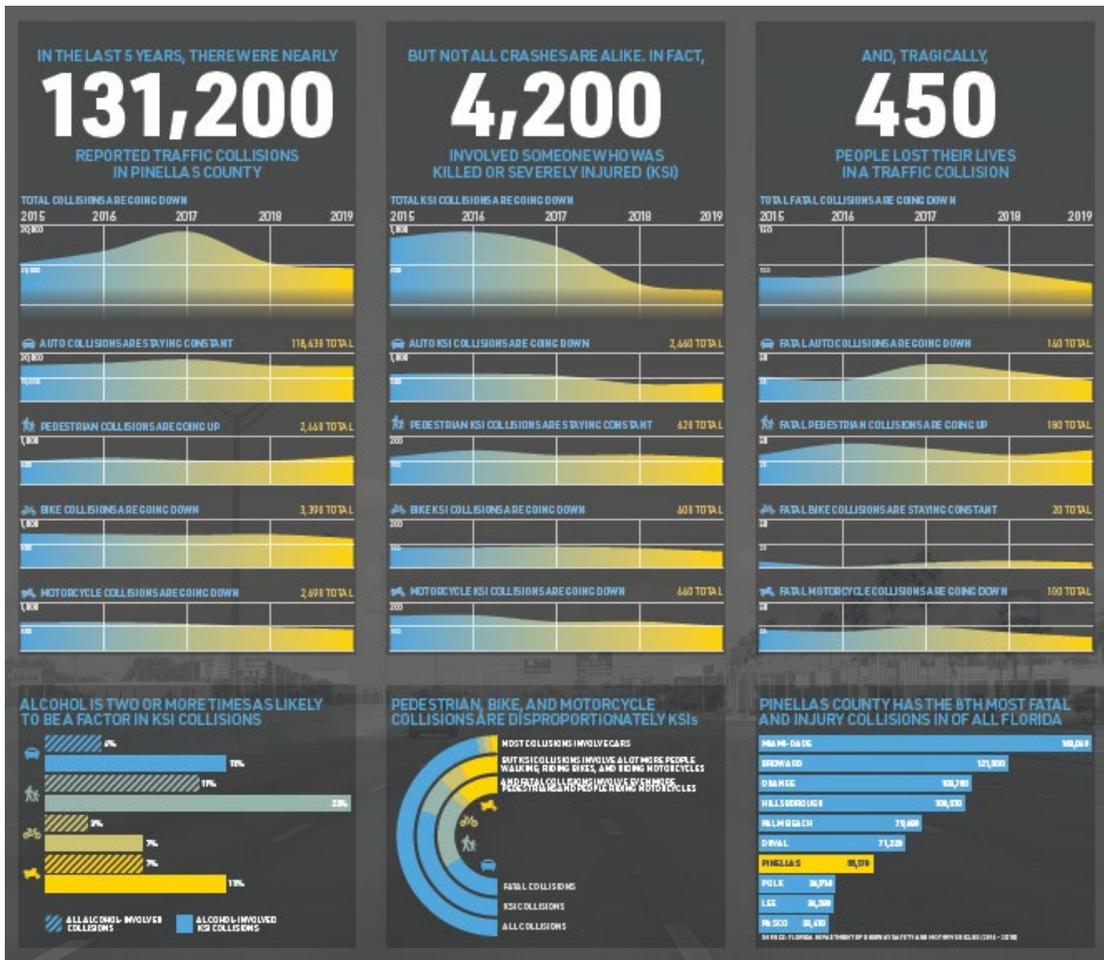
Figure 2 Collision Trends Board

- Develop informational materials, such as the collision summary board (See Figure 2)
- Develop survey instrument and QR code with printed cards and QR code displays to obtain feedback from trail users and event attendees

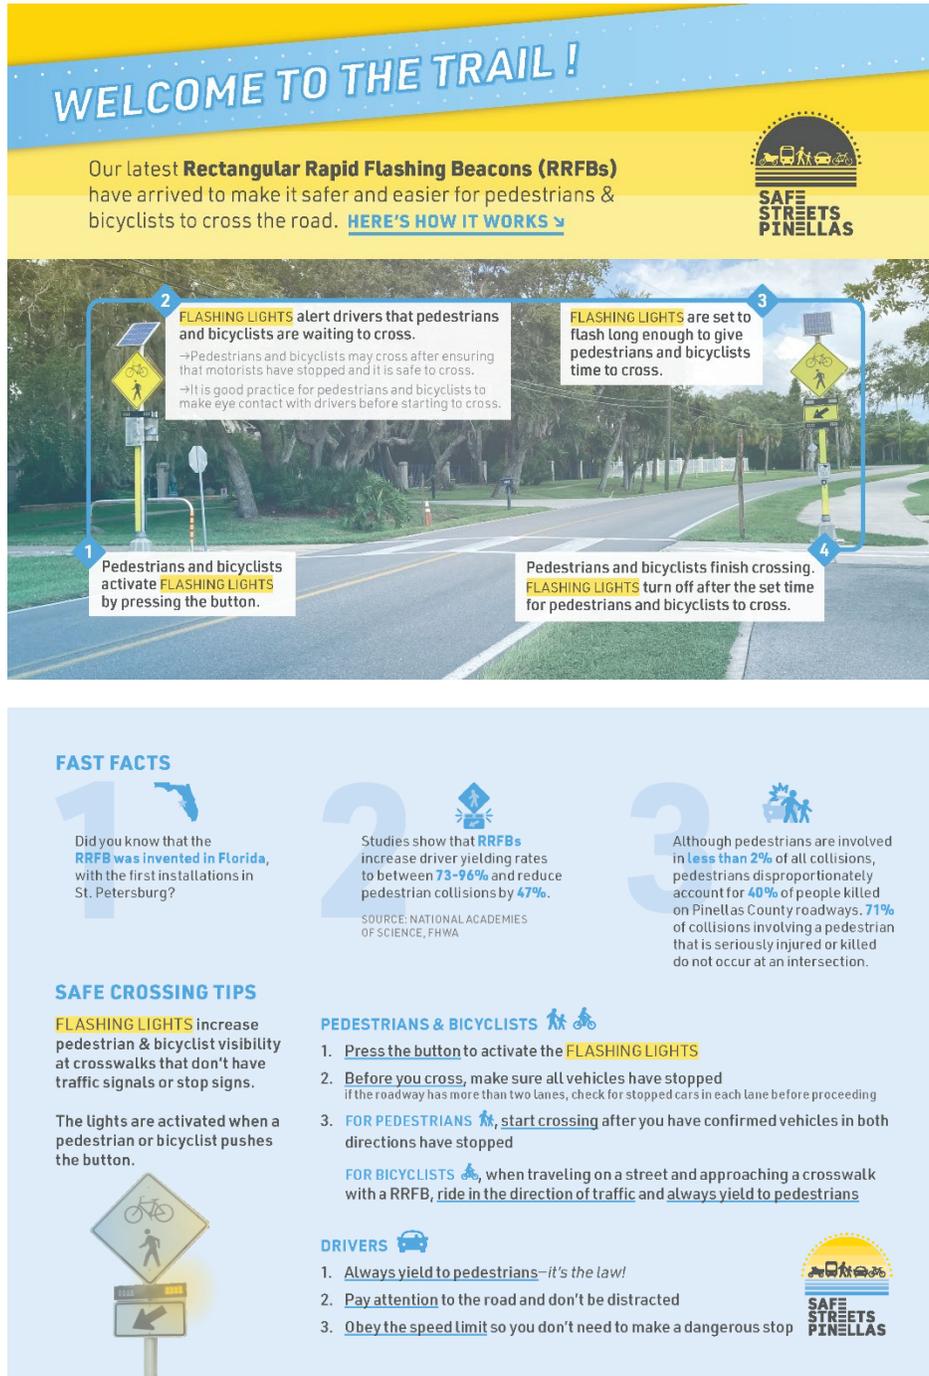
Figure 3 RRFB Educational Flyer

In addition to honoring the crash victim, Carmen Charrez, another focus of the event was to raise awareness of the purpose of RRFBs and the correct usage for all roadway users. Custom educational materials were developed and are available as a 5 X 7 flyer, as well as electronically for use on social media.

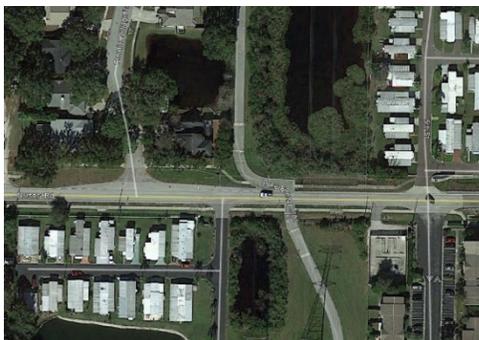
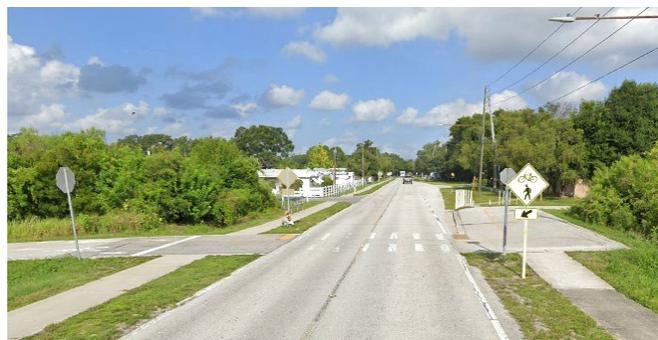
Figure 1. Duke Energy Trail Crossing at Nursery Road

As shown on Figure 1, Nursery Road is a two-lane roadway. It has a posted speed limit of 35 miles per hour, and based on data collected in 2019, the average daily traffic volumes on Nursery Road at the crossing are approximately 6,500 vehicles per day. Average speeds for vehicles approaching the crossing are in-line with the speed limit of 35 miles per hour; however, the 85th percentile speed of vehicles approaching the crossing is 40 miles per hour. On a typical summer

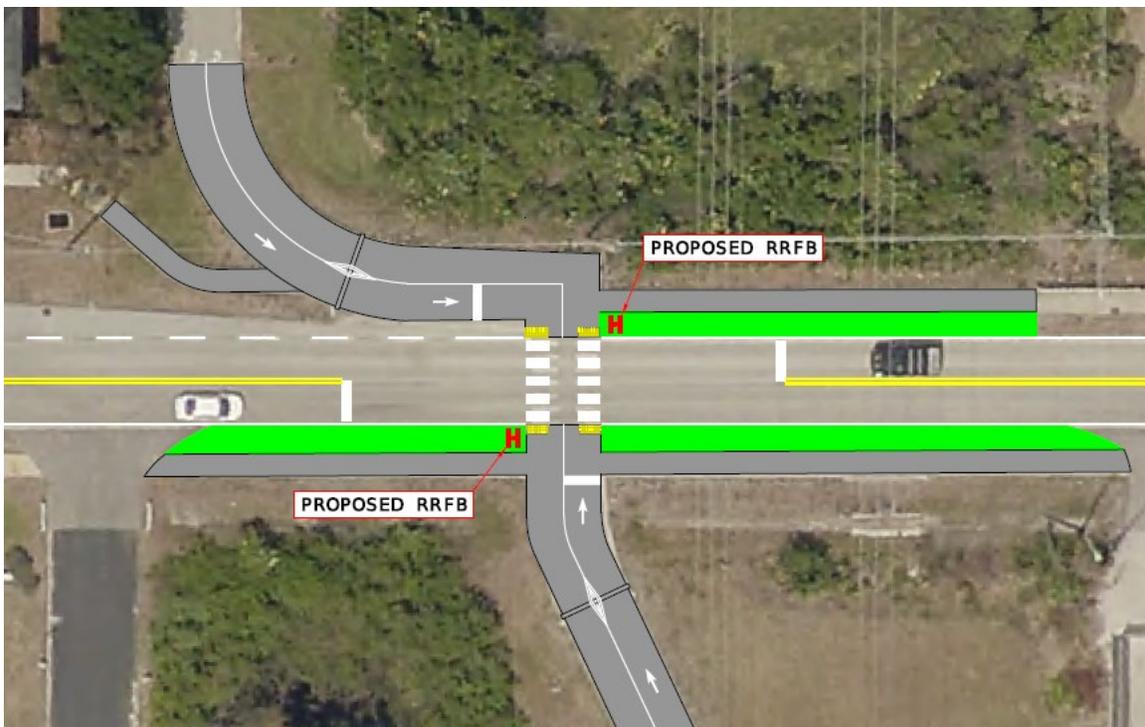
Figure 2. Preliminary RRFB Concept

Pinellas County and the City of Clearwater are planning to install a rectangular rapid flashing beacon (RRFB) at this location using the County's standard design plans for RRFBs. This installation was identified after a May 2019 collision in which a bicyclist was killed while crossing Nursery Road at the Duke Energy Trail. As part of the research conducted to determine the appropriateness of an RRFB at this location, the County collected extensive data that includes video-based trail user counts by mode, motor vehicle speed, and volume data for Nursery Road at the trail crossing. Preliminary discussions with County staff indicate installation of the RRFB could be coordinated with the demonstration project. A concept plan of the standard RRFB design at the crossing is shown as Figure 2.

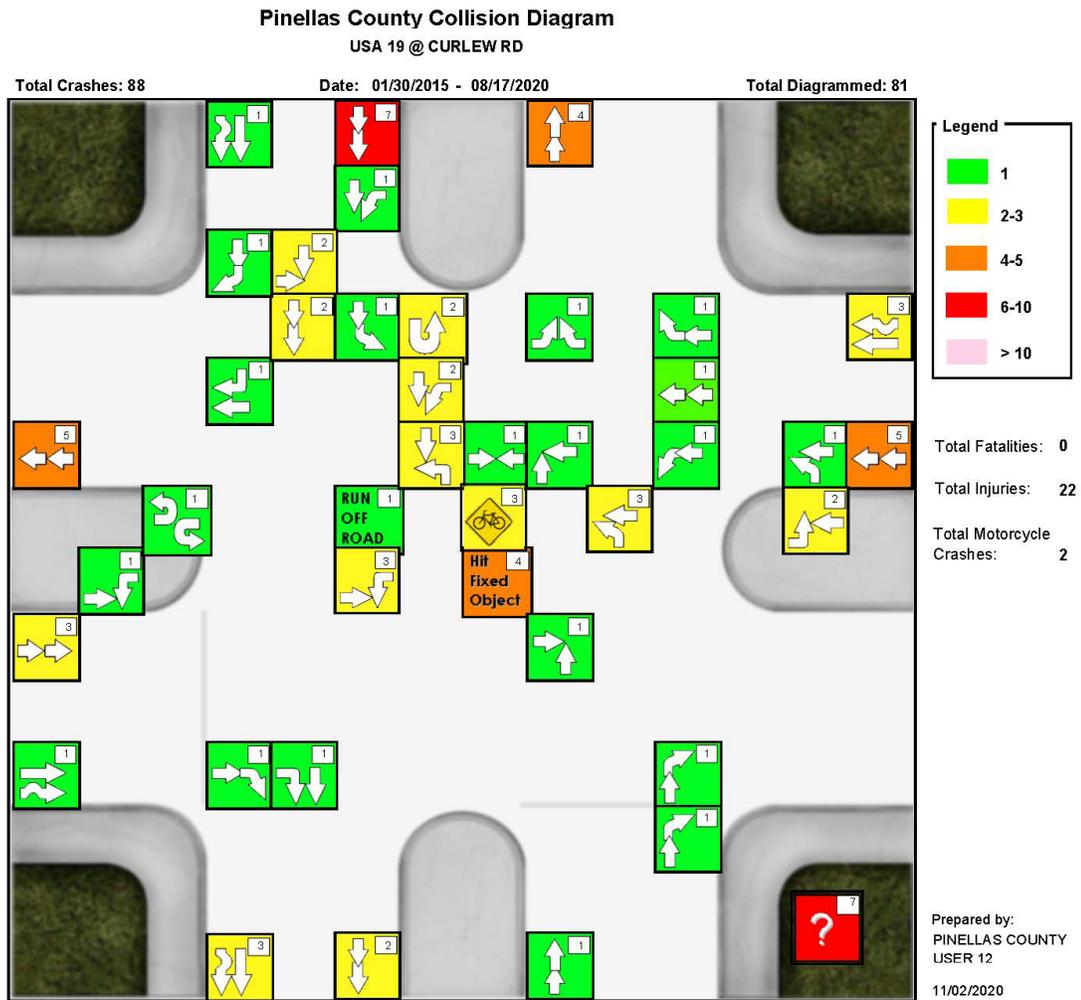
Figure 1 – Alt Route 19 at Curlew Road Collision Diagram (2015 – September 2020)

During this time period, a total of 88 collisions were reported at the intersection, including four that resulted in severe or incapacitating injuries, as shown on **Table 1**, with a collision diagram shown on **Figure 1**. Of the severe injuries, two were people riding motorcycles and two were people within a vehicle. Four collisions involved a person riding a bicycle, and one collision involved a person walking; injuries were not reported in those collisions. Collision types are presented in **Table 2**, which shows that rear-end collision are the most frequent collision types at the intersection (42 percent), followed by angle (14.8 percent), sideswipe (11.4 percent), and left-turn (10.2 percent). A rear-end collision is when the rear of one vehicle impacts the rear of another. An angle crash occurs when two vehicles impact at an angle – for example, the front of one vehicle impacts the side of another vehicle. Sideswipe collisions are when two vehicles traveling in the

same direction impact where the initial engagement does not overlap the corner of either vehicle. The impact swipes along the surface of the vehicle parallel to the direction of travel. Left-turn collision involve at least one vehicle turning left. In most instances, the other vehicle is traveling straight. **Table 3** presents contributing factors, which primarily include people driving in a negligent manner (41 percent), unknown or no information (28 percent), failing to yield right-of-way (10 percent), and following too closely (9 percent).

Comparing the location of actual collisions to the location of near-misses, nine of the reported collisions involved a permitted left-turn movement and a through movement, meaning that the near-miss analysis is reflective of observed collision data. For collisions involving permissive left-turn movements, no severe or fatal injuries occurred. Other observed near-misses correlate to angle collisions, especially in the southeast and southwest corners of the intersection.

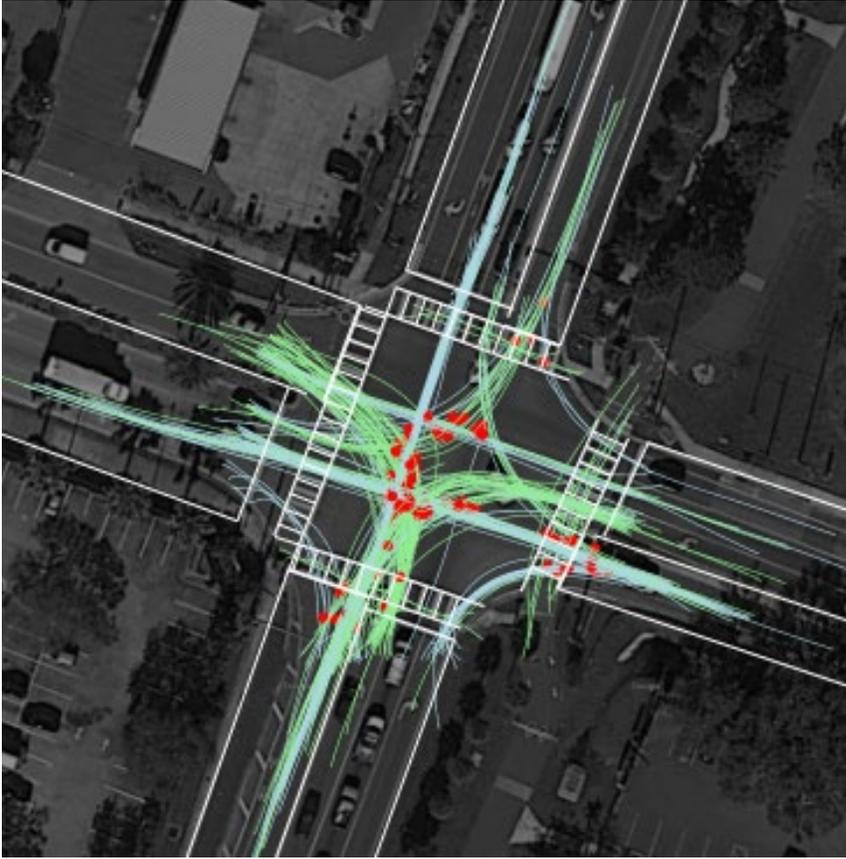
Figure 2 All Near Misses with PET < 2.0 (August 23 and 24)

The PET value is an indicator of how close two roadway users were to occupying the same space at the same time. The smaller the PET value, the closer roadway users were to colliding. Within the observed data for Alt Route 19 at Curlew Road, the lowest PET value documented was 0.3 seconds for the data collection window. There were 3,003 roadway user interactions with an observed PET value between 0.3 and 5 seconds, or about 3.1 percent of roadway movements. A review of select videos with a PET value between 2 and 5 indicates that many of these

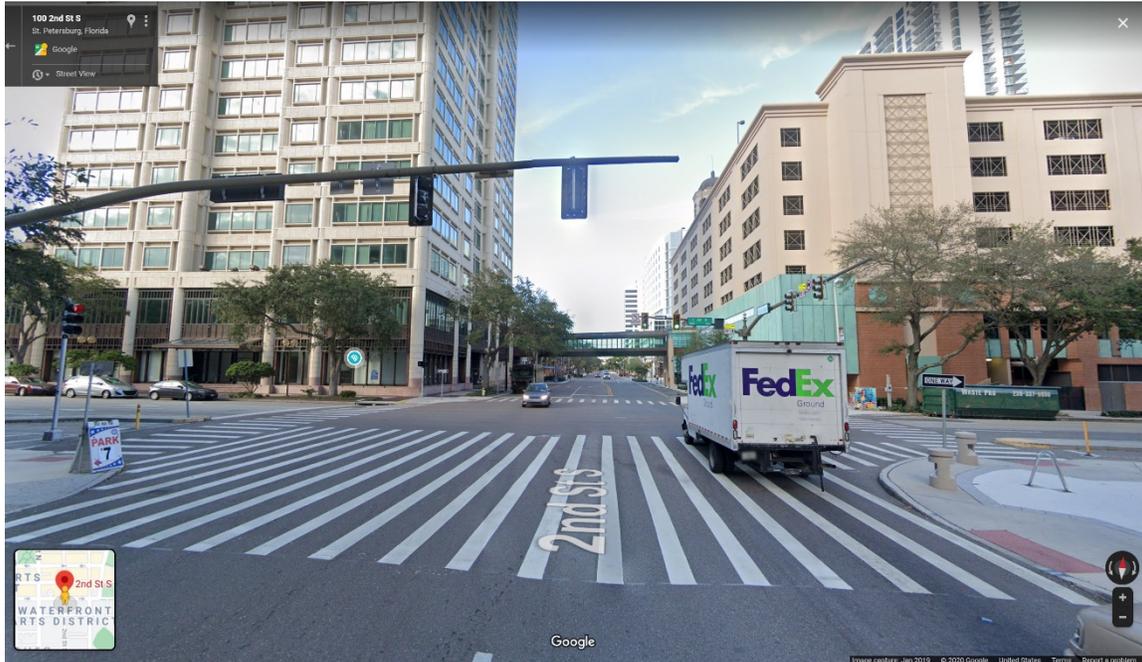
Figure 1

The City of St. Petersburg has identified the intersection at 1st Avenue S and 2nd Street S as a location to test the effectiveness of protected intersection concepts, as the intersection incorporates an urban crossing of the Pinellas Trail and has a high volume of bicycle and pedestrian travel that conflicts with turning vehicles. In 2008, the extension of the Pinellas Trail into downtown St. Petersburg opened using a repurposed travel lane along the south side of 1st Avenue S and is Florida's first urban cycle track. This segment of the trail travels within an urban environment along a one-way street with on-street parking and dense intersection spacing. Collision history at this intersection is minimal, but as bicyclists and users of the trail have increased, the potential for additional conflicts with vehicular traffic is rising and numerous close calls have been observed at several intersections along 1st Avenue S. Safety improvements along the trail are under consideration by the City and protected intersection treatments at 5th Street S and 6th Street S have already been designed with initial concepts. A street level Google Maps image of the intersection is provided in Figure 1.

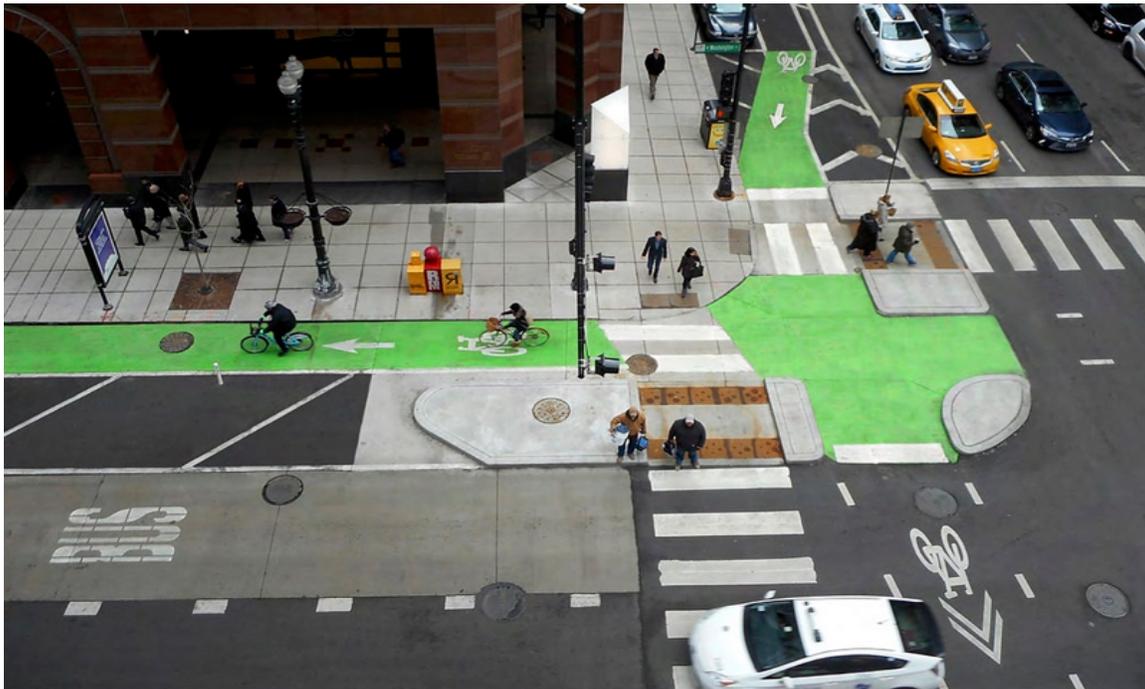
Protected intersections improve safety for bicyclists and pedestrians as they cross intersections. Corner islands, curb extensions, and colored paint are used to delineate the bicycle path across an intersection, parallel to the crosswalk and can allow a two-stage left turn. Figure 2 is an example of a protected intersection.

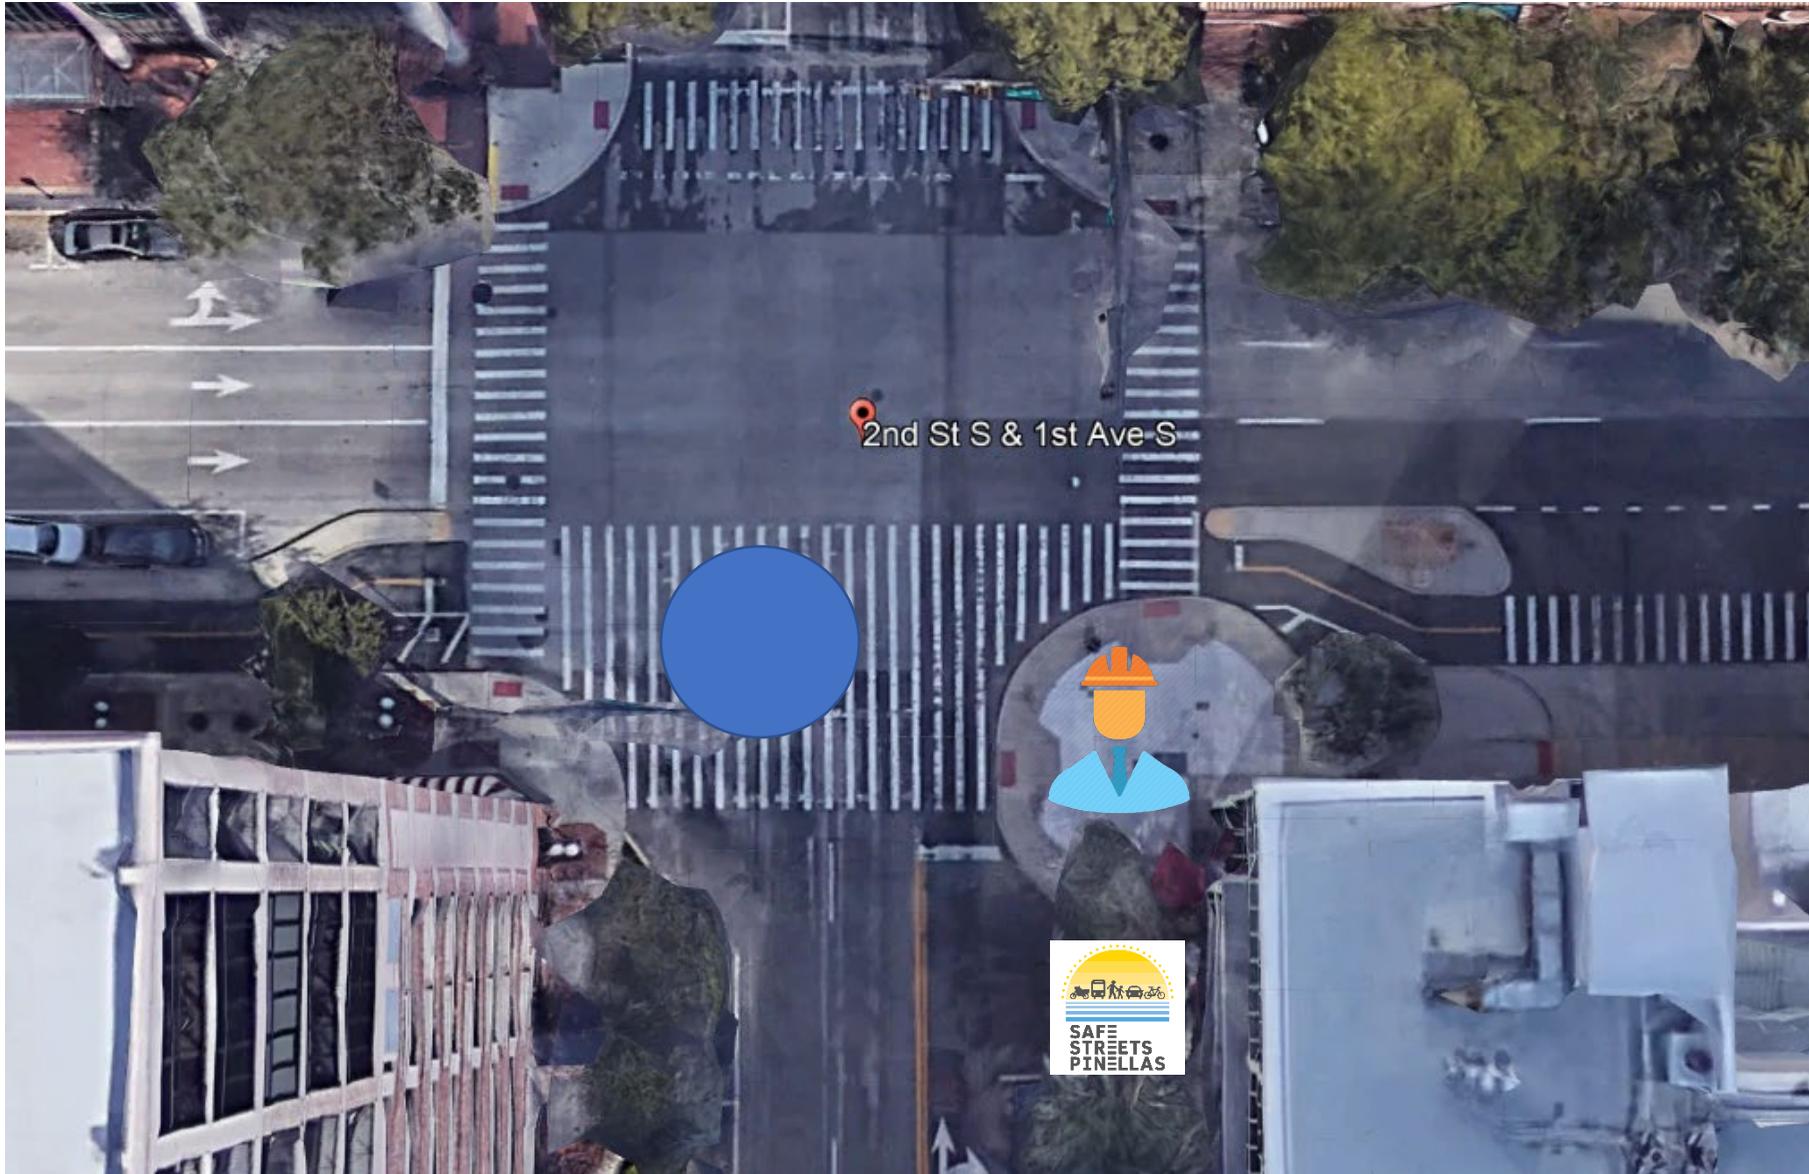
Before device installation configuration:

It is recommended that the observer locate on the southeast corner of the intersection as the focus of the data collection effort is the eastbound right-turn movement with a primary focus on driver speeds across the crosswalk (see blue area) for right-turning vehicles, and overall roadway user behavior. There are bollards that could be used as informal seating (or bring a chair), or if you are lucky, you might snag the prime parking spot where the Safe Streets logo is placed (don't forget to pay for parking!) Please take some pictures to share, and bring business cards as people may stop and ask what you are doing. You can direct people to contact Cheryl Stacks at 727-892-5328 or cheryl.stacks@stpete.org with questions. Please coordinate your data collection time periods with Cheryl so she can inform their Downtown Police Offices to the activity.
